**EXPERT REPORT**

**EDWARD JAMES MORTON**

**Subject Property** : **The Futurist Cinema, Lime Street, Liverpool**

**Inspection Dates** : **Tuesday 19<sup>th</sup> April 2016 (Edward Morton)**  
**Tuesday 10<sup>th</sup> May 2016 (Rik Fox)**

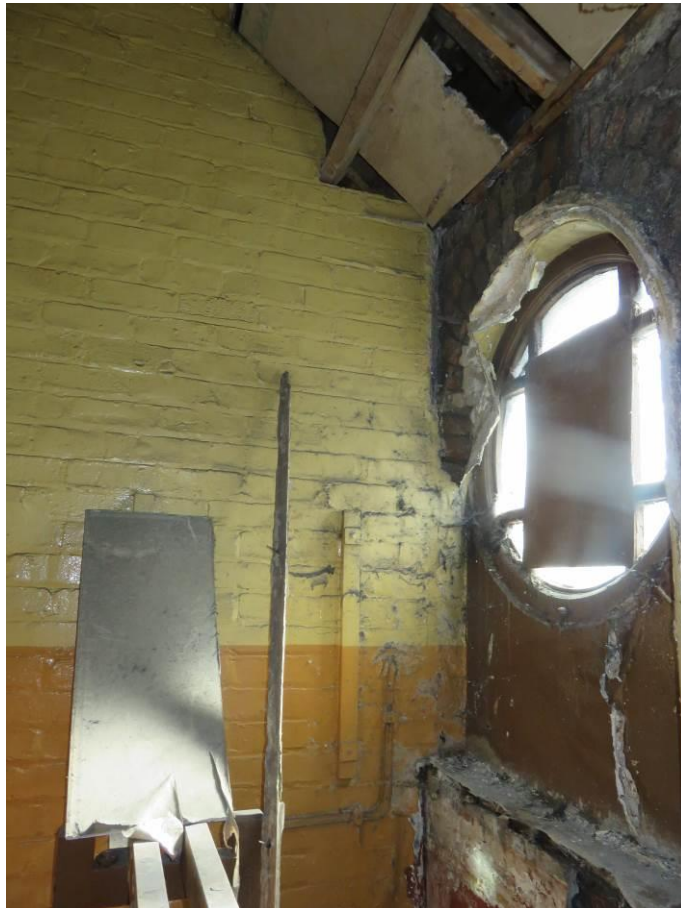
Photograph 1: Cross wall to front elevation providing lateral restraint and with no evidence of cracking

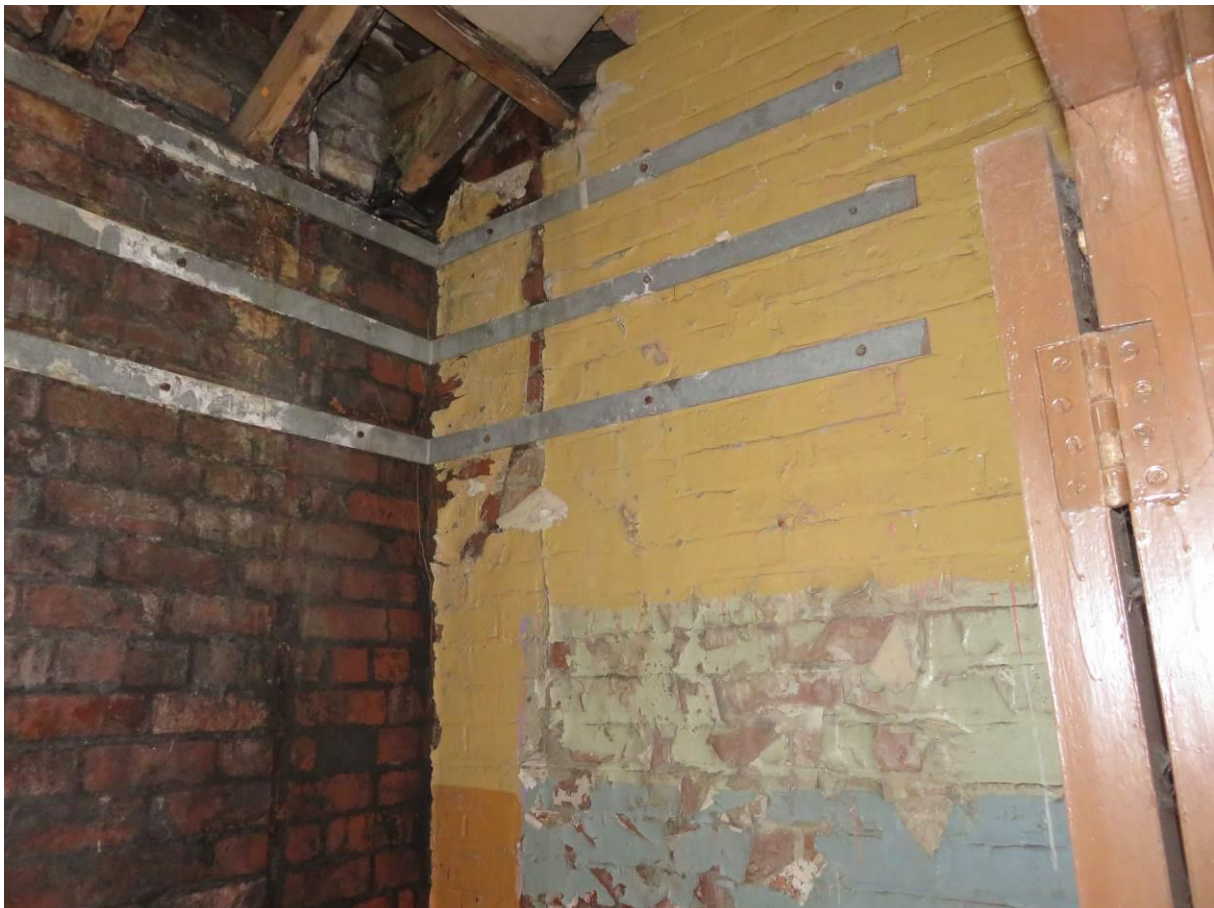
Photograph 2: Cross wall with temporary restraint straps

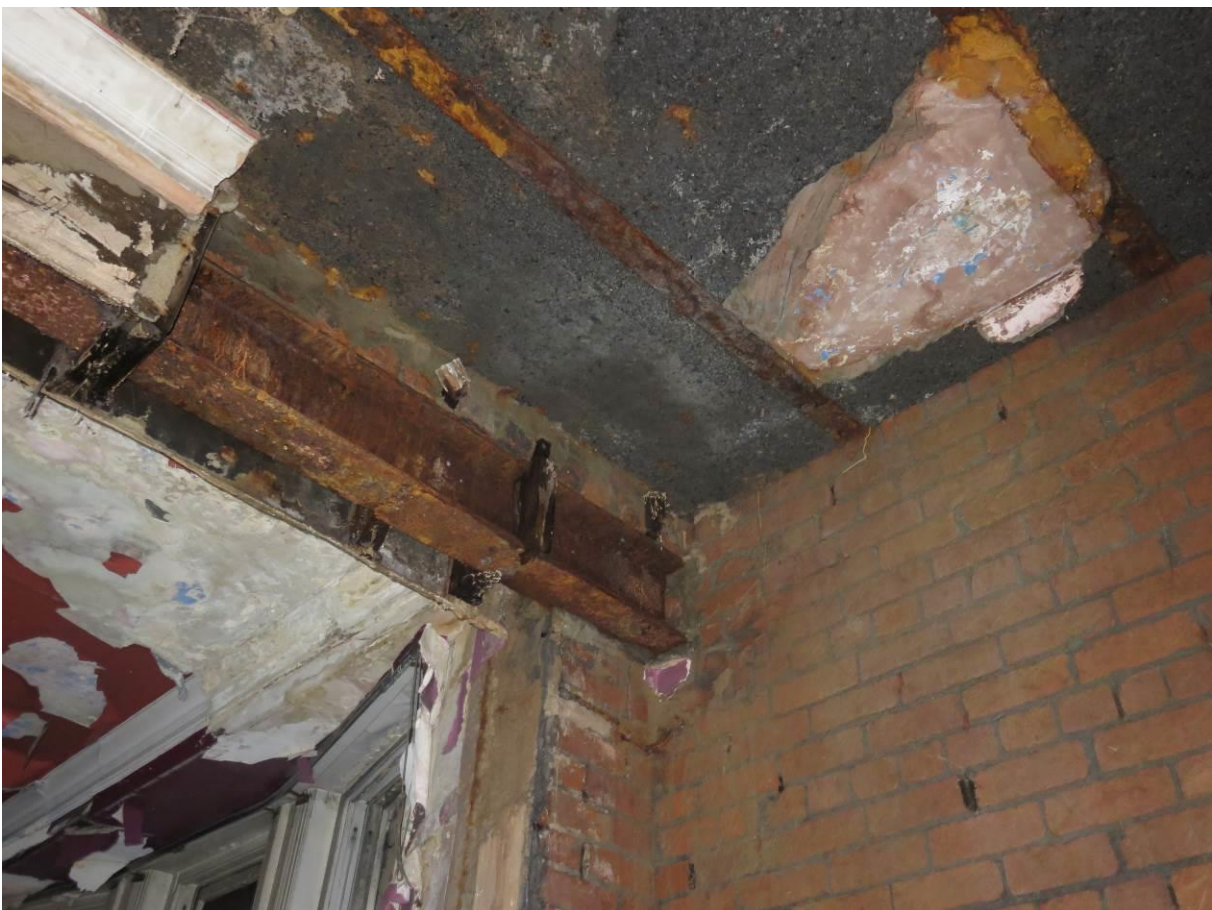
- 3.2.5** It is suggested that the floors, and in particular the in-built steels, have corroded and are aggravating the movement to the front elevation. Where the main second floor steels are built in there is some corrosion but this has not resulted in any significant cracking where they are built in to the front elevation which would be clearly evident if this had occurred. Thus these still have an important role to play in providing lateral stability. They do bear on steel lintels to the rear which require temporary support.

Photograph 4: Steel beam to front elevation with no evidence of corrosion jacking to built-in end

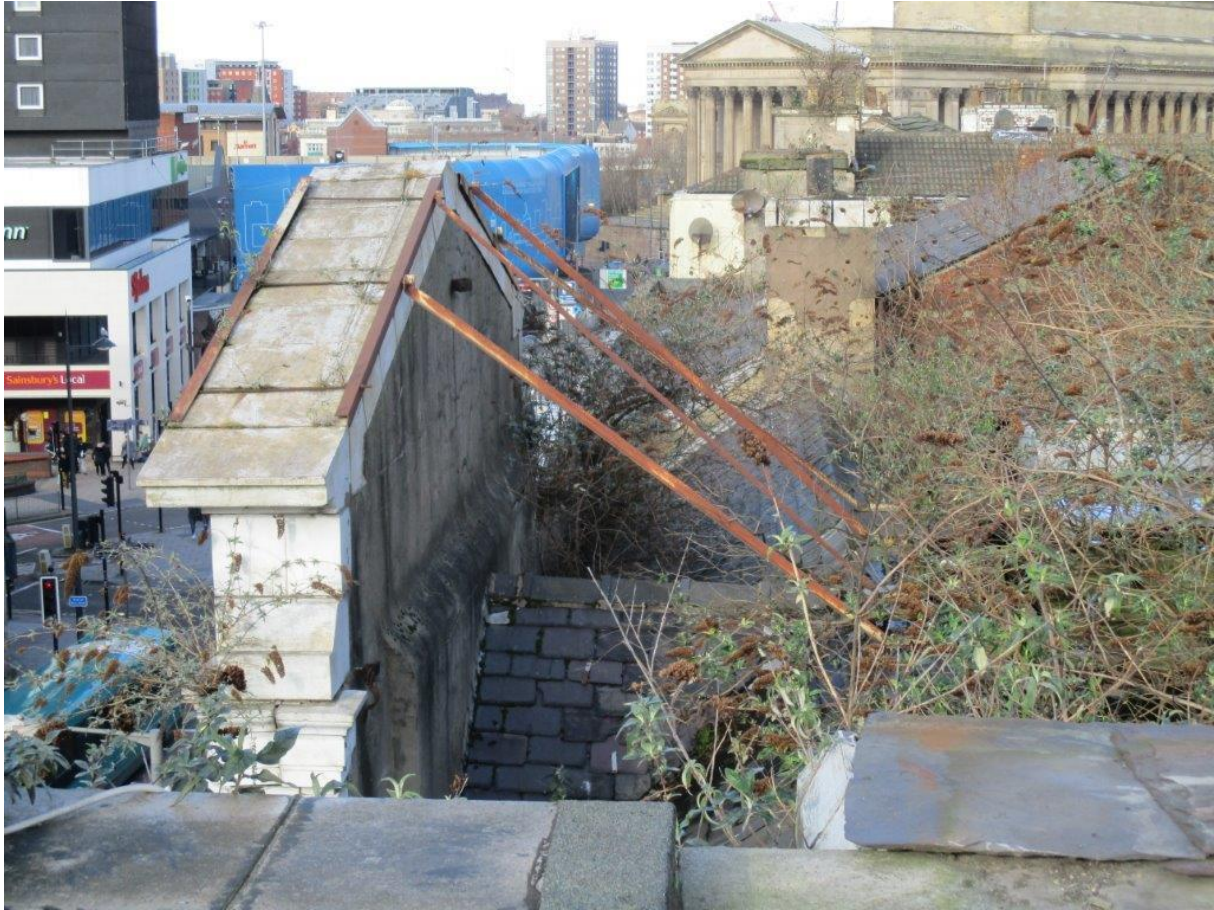
Photograph 5: Restraint straps to pediment

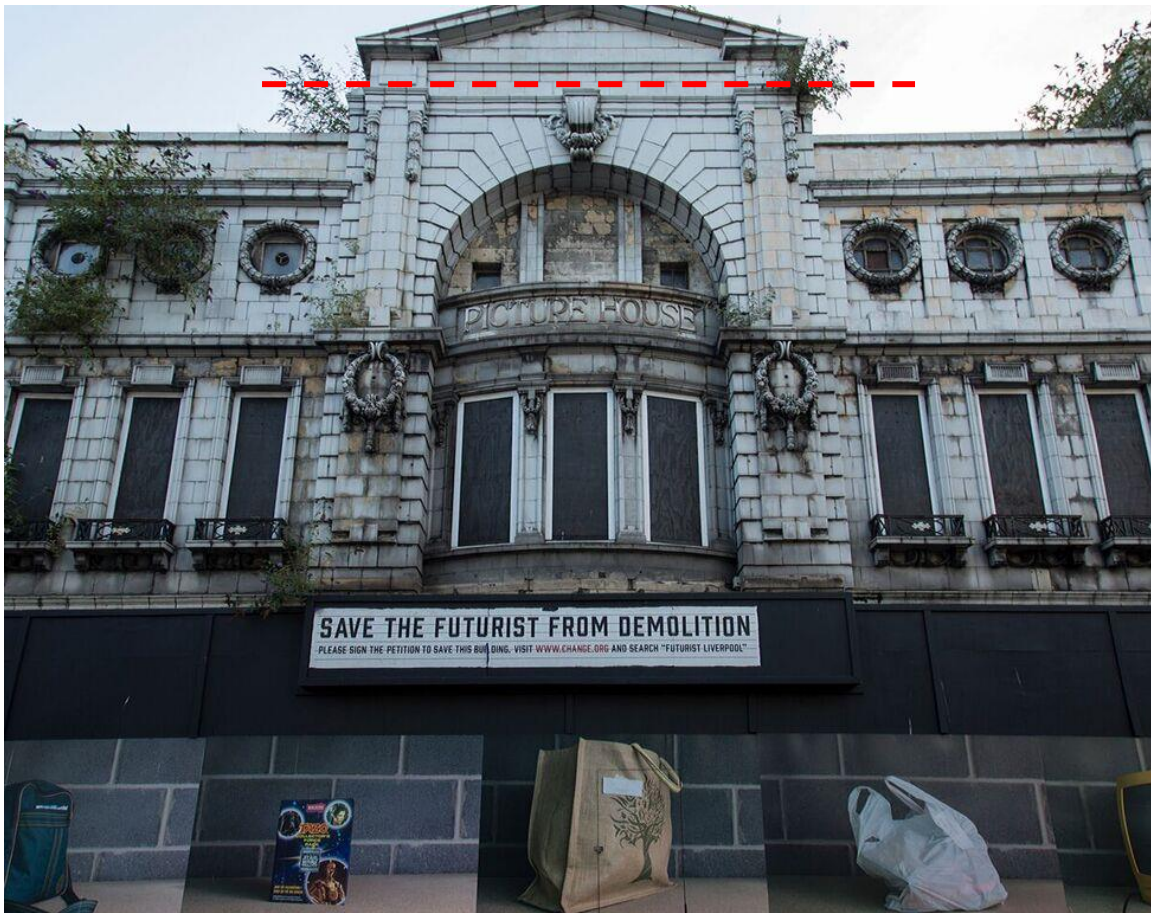
Photograph 7: Suggested position of dismantling

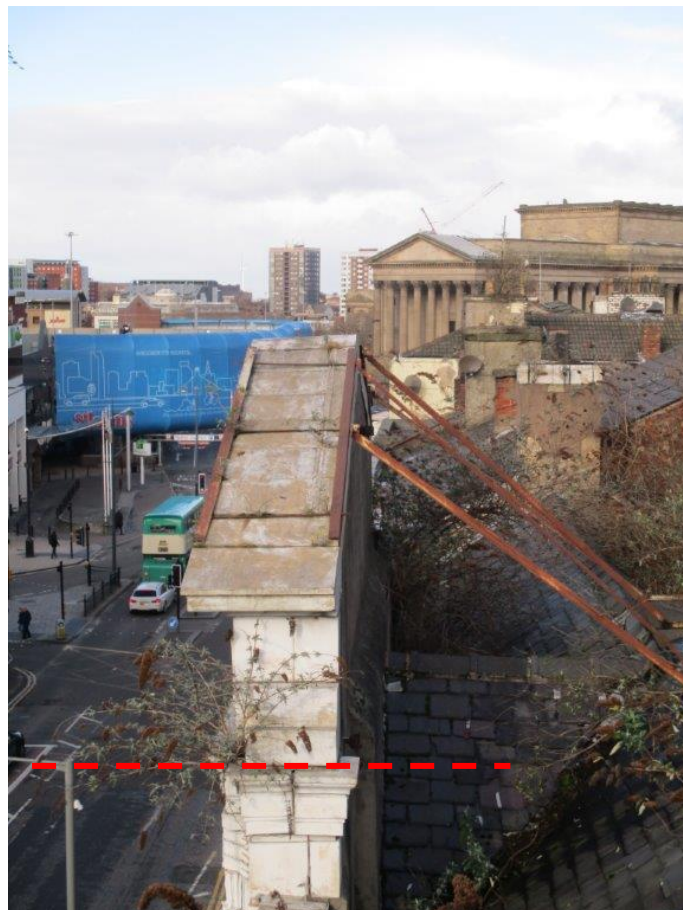
Photograph 8: Suggested position of dismantling

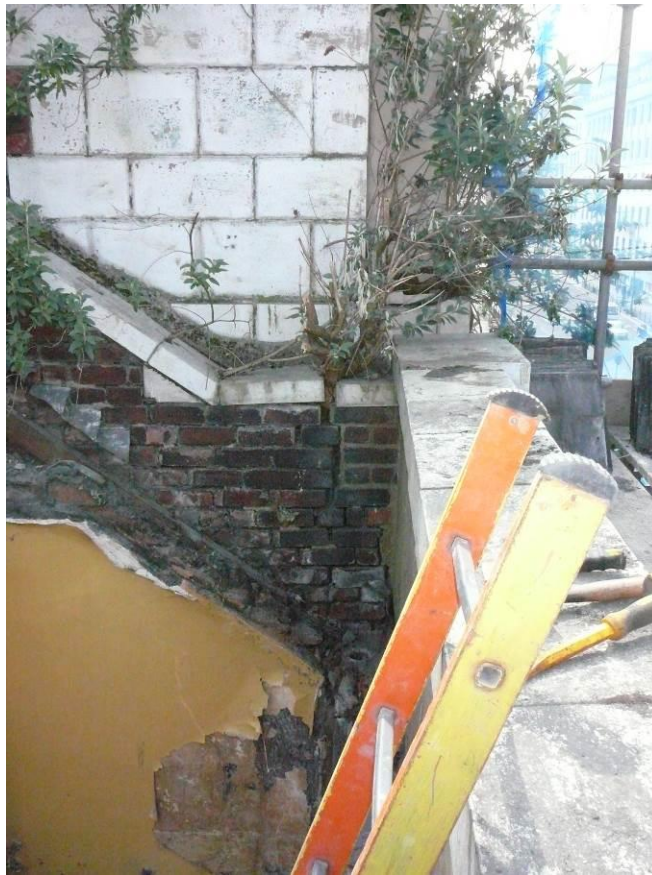
**3.2.3** There is clear evidence of movement to the upper part of the building with out of plumb noted, and including root growth which has widened joints and pushed the wall out locally (see photograph 3). These were highlighted in the Sutcliffe February 2015 report (clause 6.2.1 4<sup>th</sup> bullet point and also highlighted in associated photographs) suggesting that this was causing stone setts to become loose and unstable. I note nothing was done at that time to either kill the vegetation or consolidate the units.

Photograph 3: Buddleia growth to end wall causing opening of joint

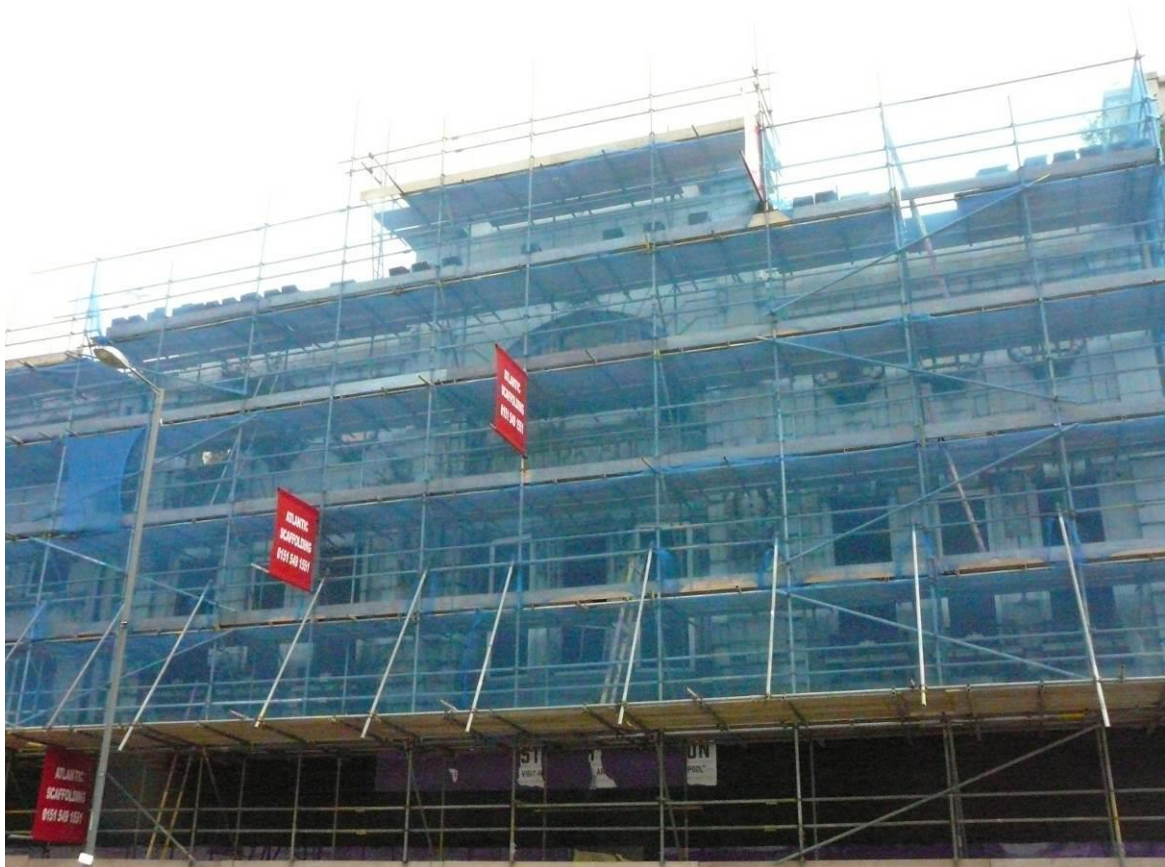
Photograph 4: The Futurist on 10<sup>th</sup> May 2016 with scaffold erected

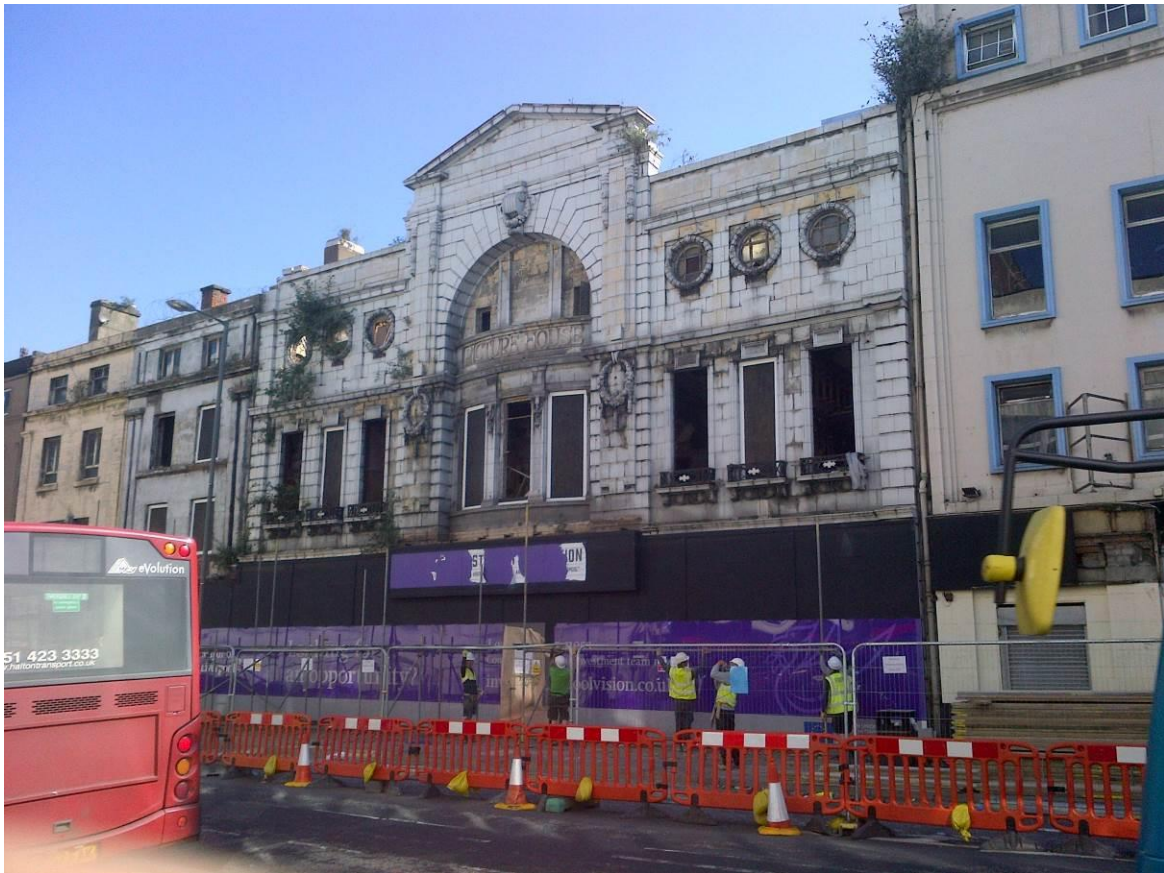
- 4.10** It is disappointing, and surprising, that the scaffold erected has been removed. Firstly it is noted this was fixed to the front elevation via anchors and through windows when erected, even though the Council has concerns about the wall stability, rather than a free standing and buttressed scaffold, accepting that this would extend further into Lime Street. Secondly if the front wall was so at risk, as suggested, then the scaffold may have afforded some additional restraint, although it this may have been limited.

Photograph 5: The Futurist on 14<sup>th</sup> May 2016 with scaffold largely removed

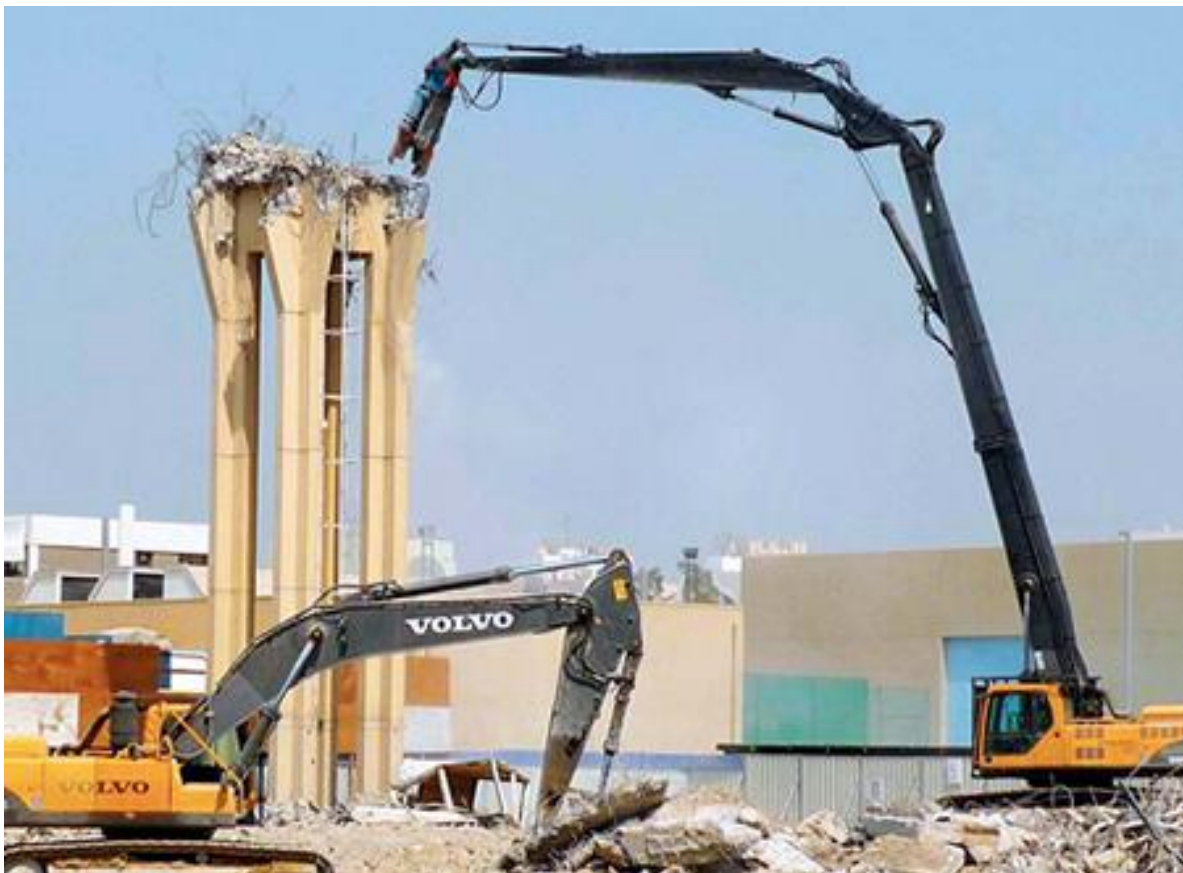
- 4.1** The Council now consider that the most appropriate method of 'deconstructing' the front elevation is to use remote high level plant. This process, in my experience is relatively uncontrolled method of work which will cause elements to fall internally and externally. A methodology or risk assessment for the works has not be seen but photograph 6 shows the type of plant this it is assumed will be used. This will clearly have an impact on the use of Lime Street, and thus the suggestion that a road closure will be necessary.

Photograph 6: High level Plant being used for demolition
