The Morton Partnership
Structural Engineers

Registered in England No. 2727193

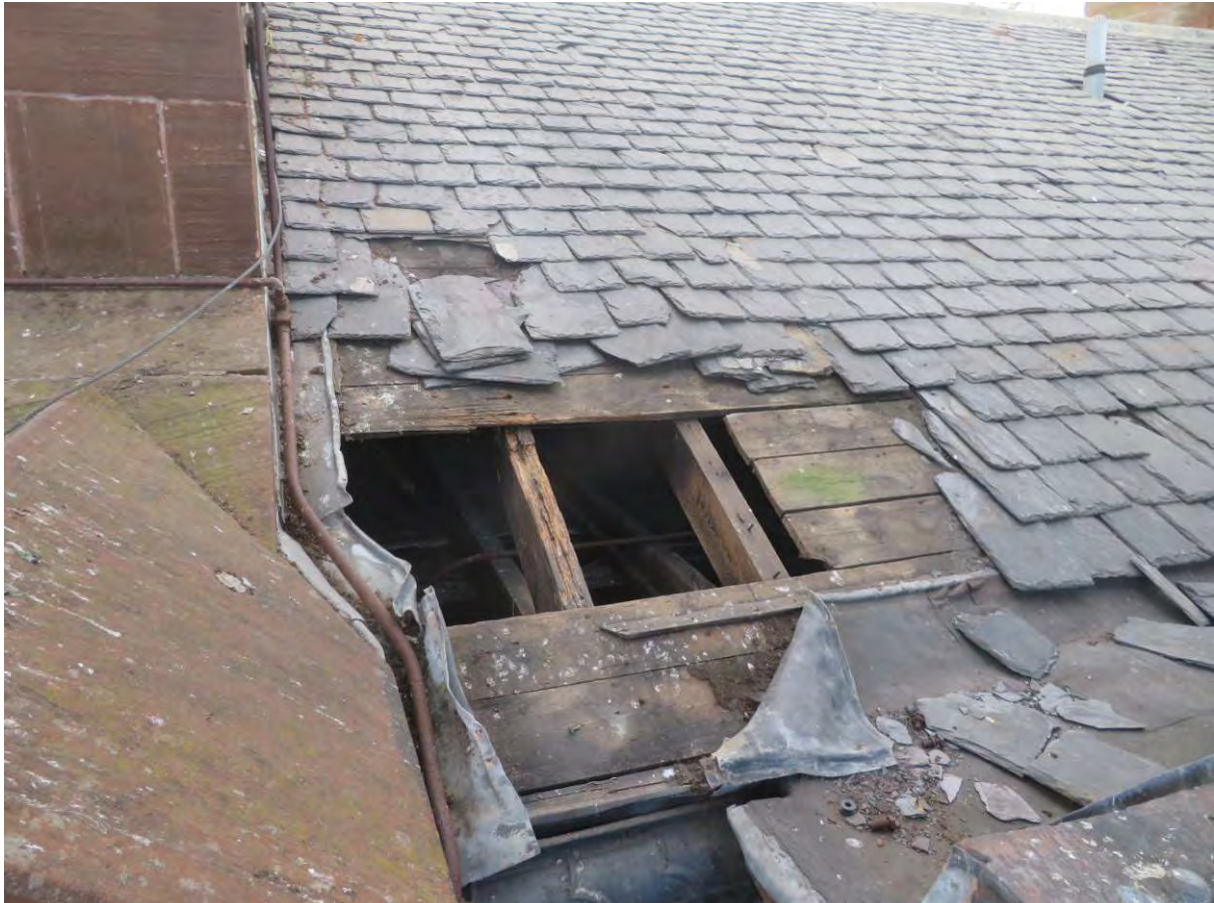
Photograph 18: Local decay to roof structure through water ingress

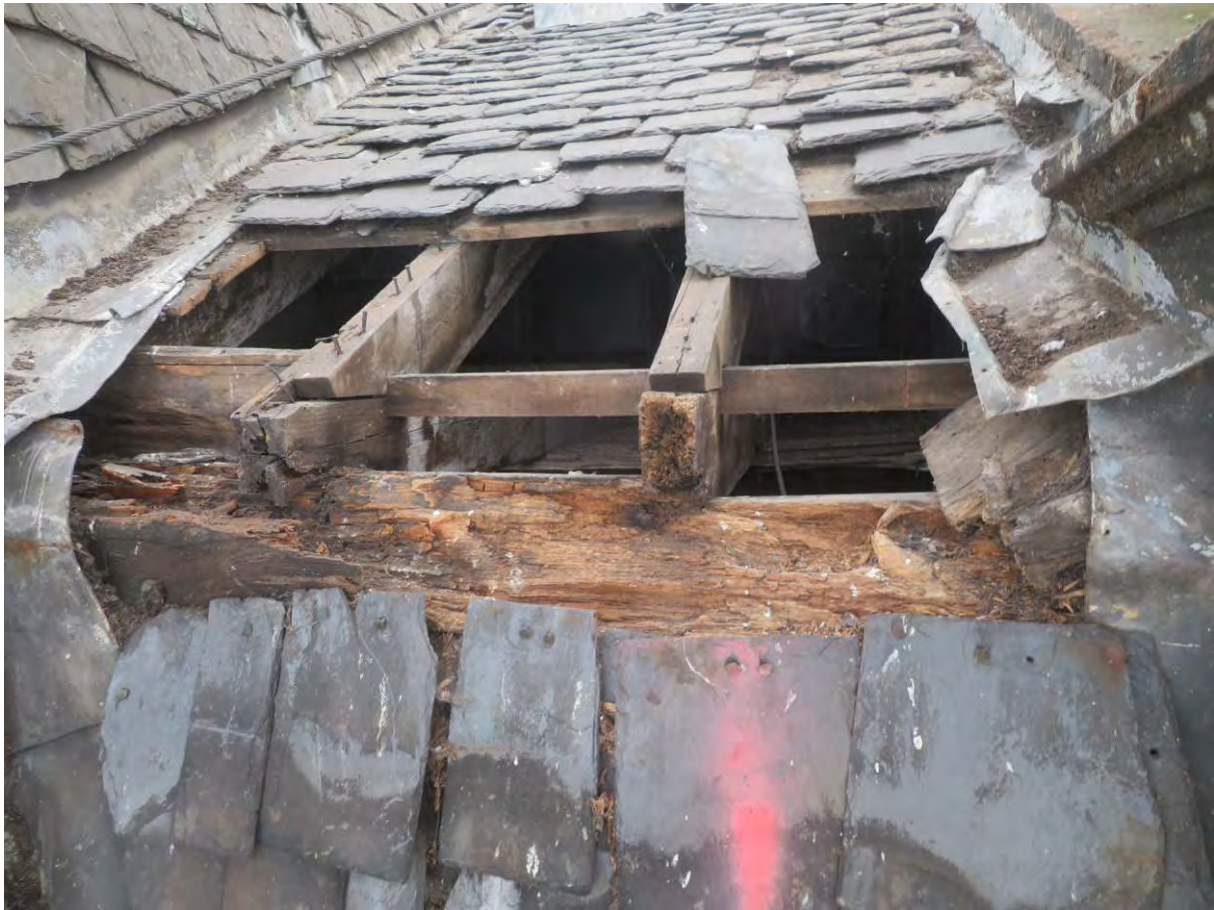
Photograph 19: Local decay to roof structure through water ingress to east elevation

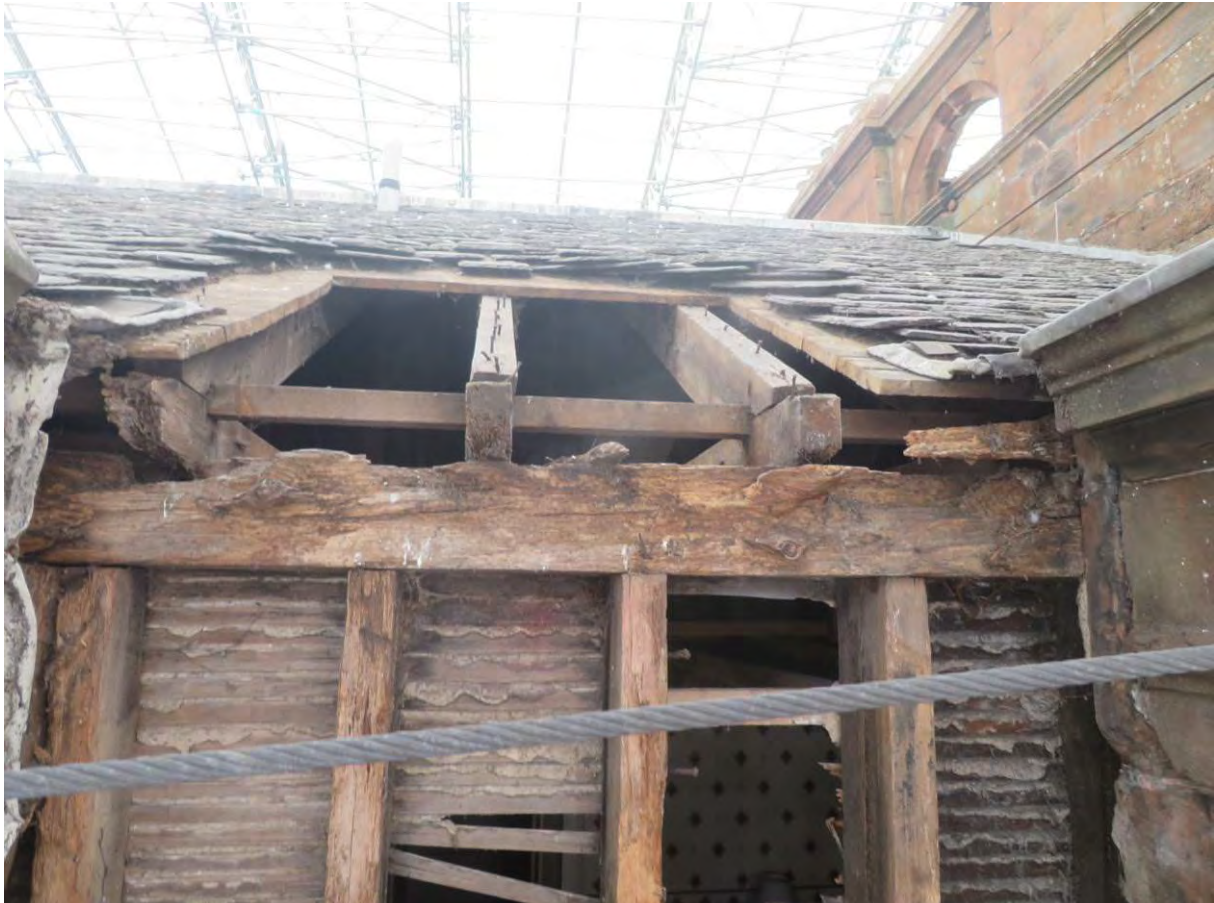
Photograph 20: Local decay to roof structure through water ingress to east elevation

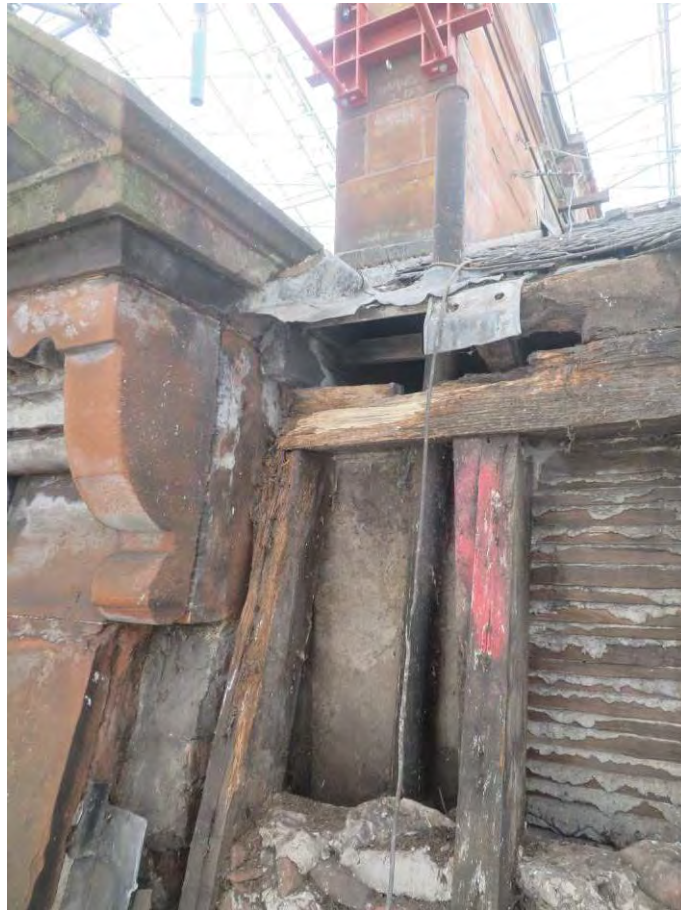
Photograph 21: Local decay to roof structure through water ingress to east elevation

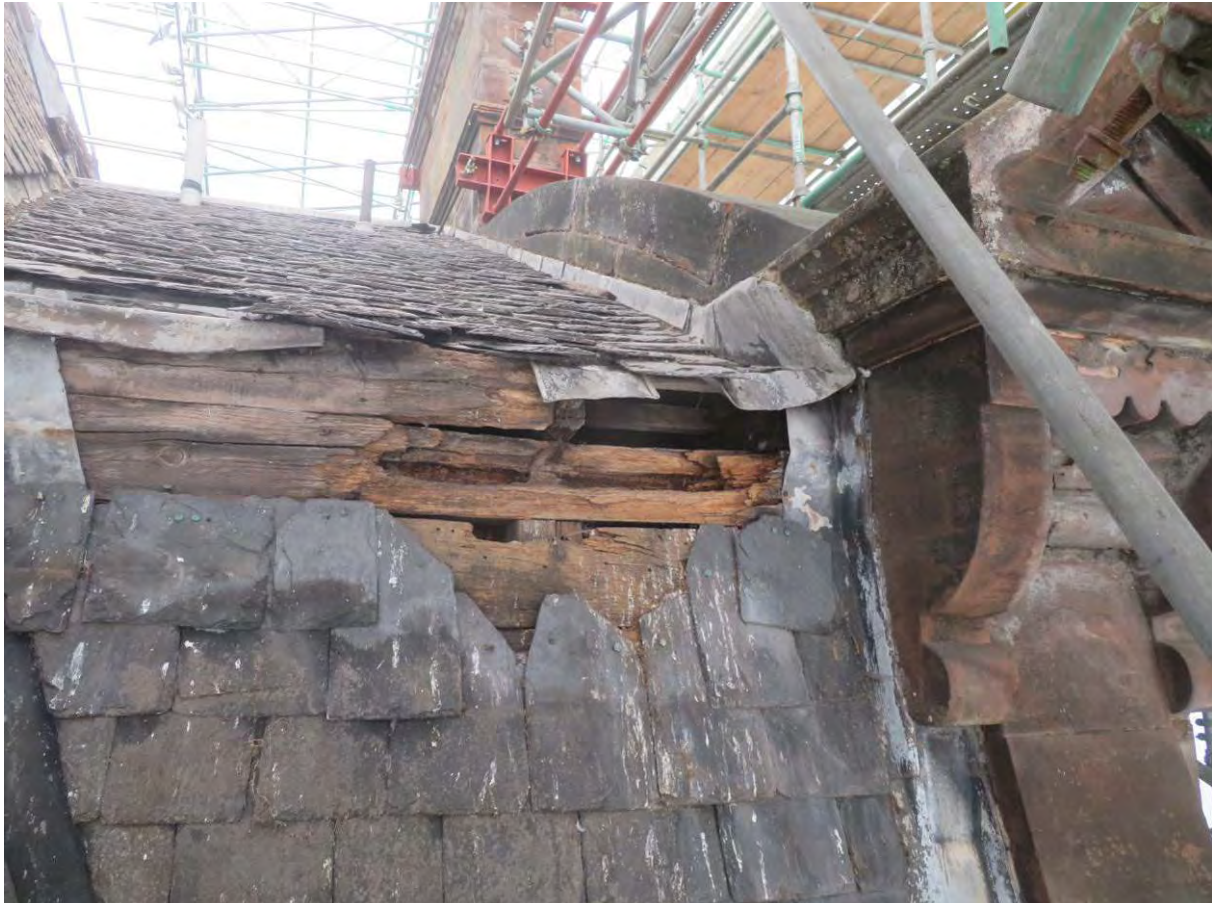
Photograph 22: Local decay to roof structure through water ingress to east elevation

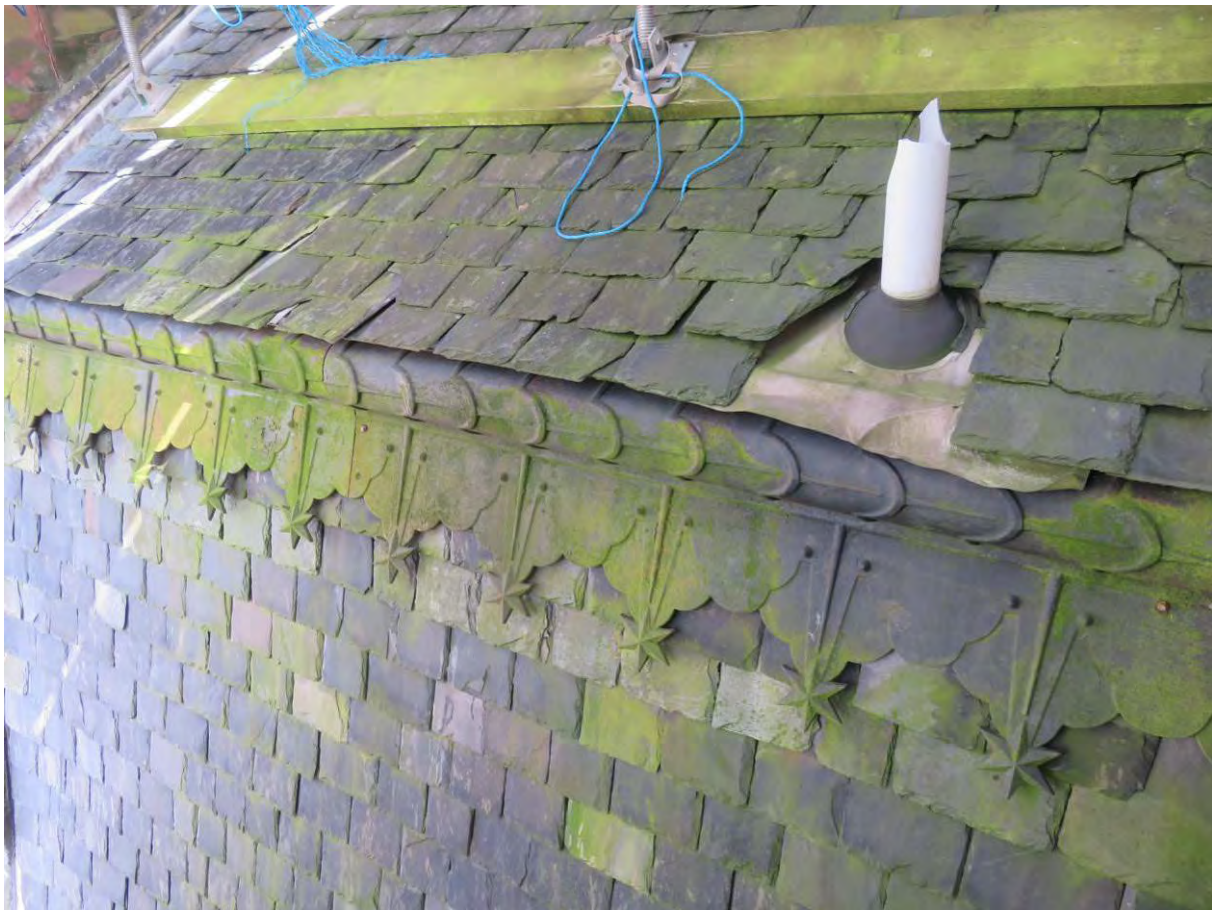
Photograph 23: Cast iron weathering between roof pitches to south range mansard

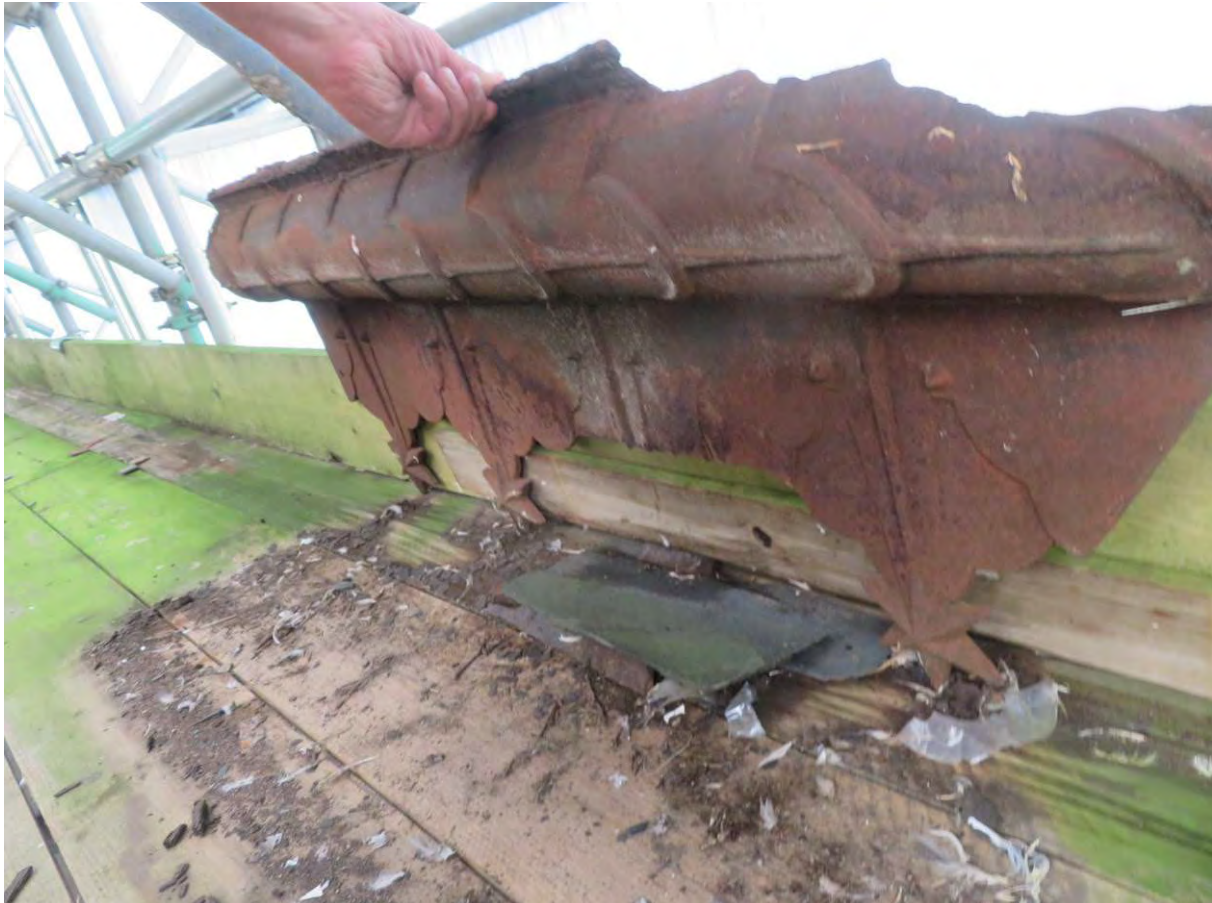
Photograph 24: Broken section of cast iron weathering

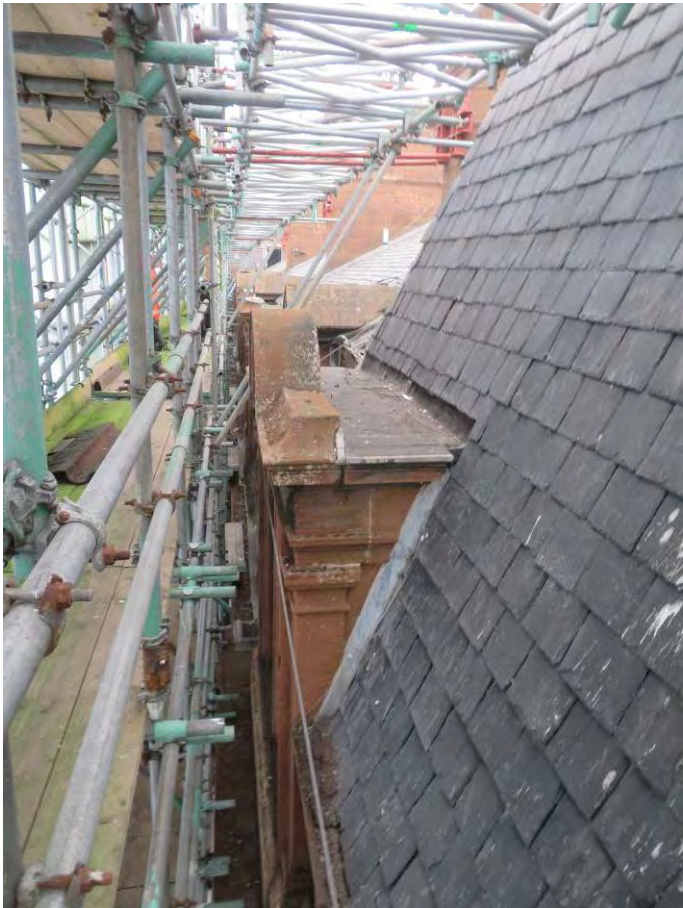
Photograph 25: Pedimented dormer to west elevation

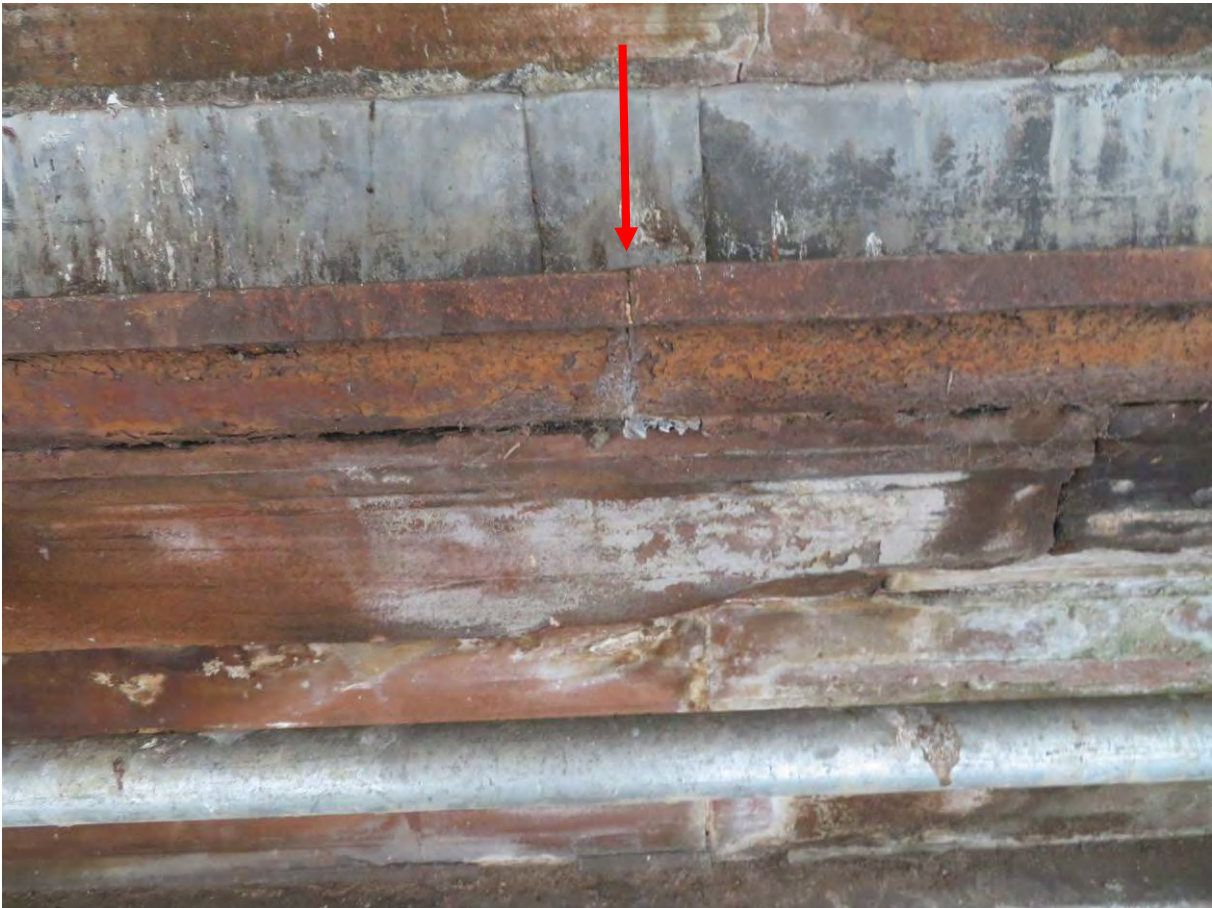
Photograph 35: Damage to stone below gutter joint

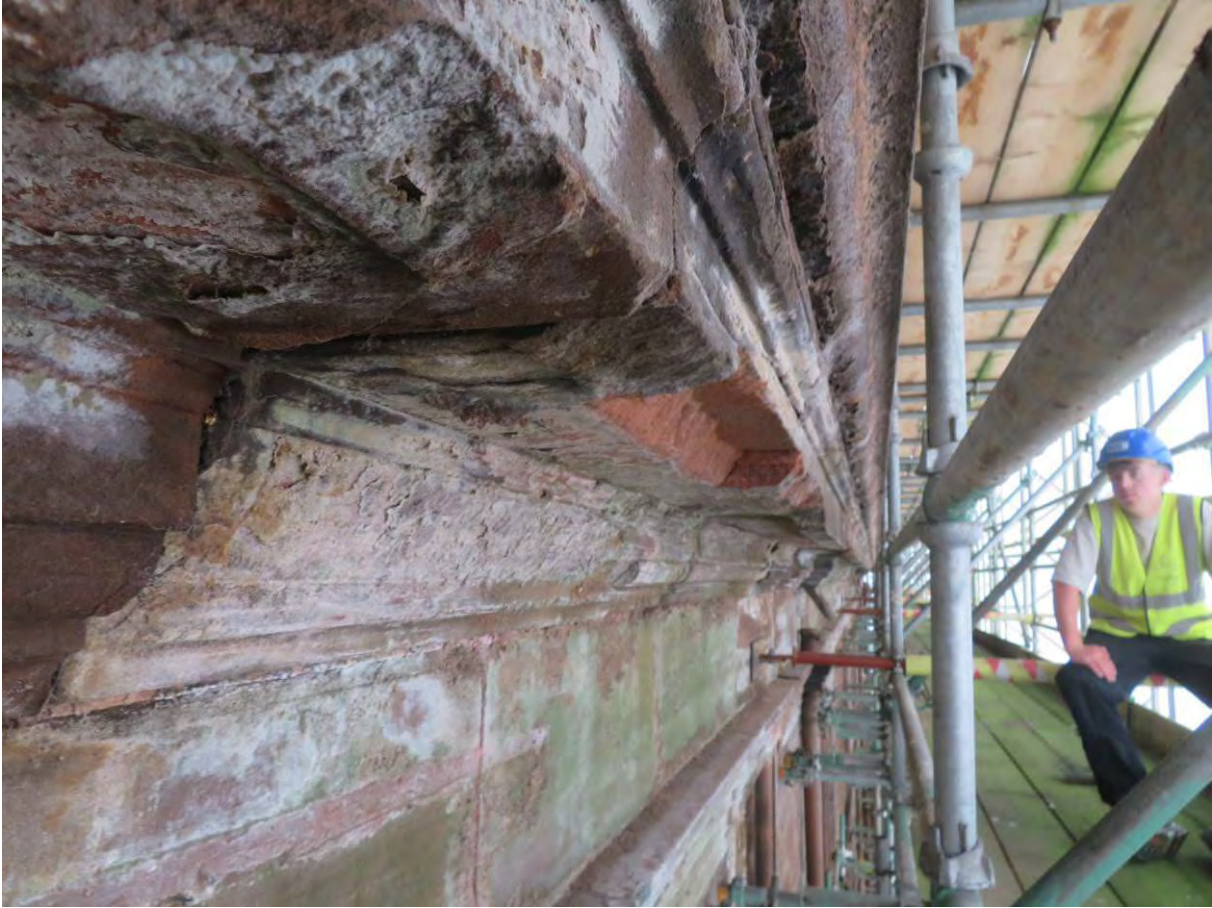
Photograph 36: Damage to stone below defective gutter

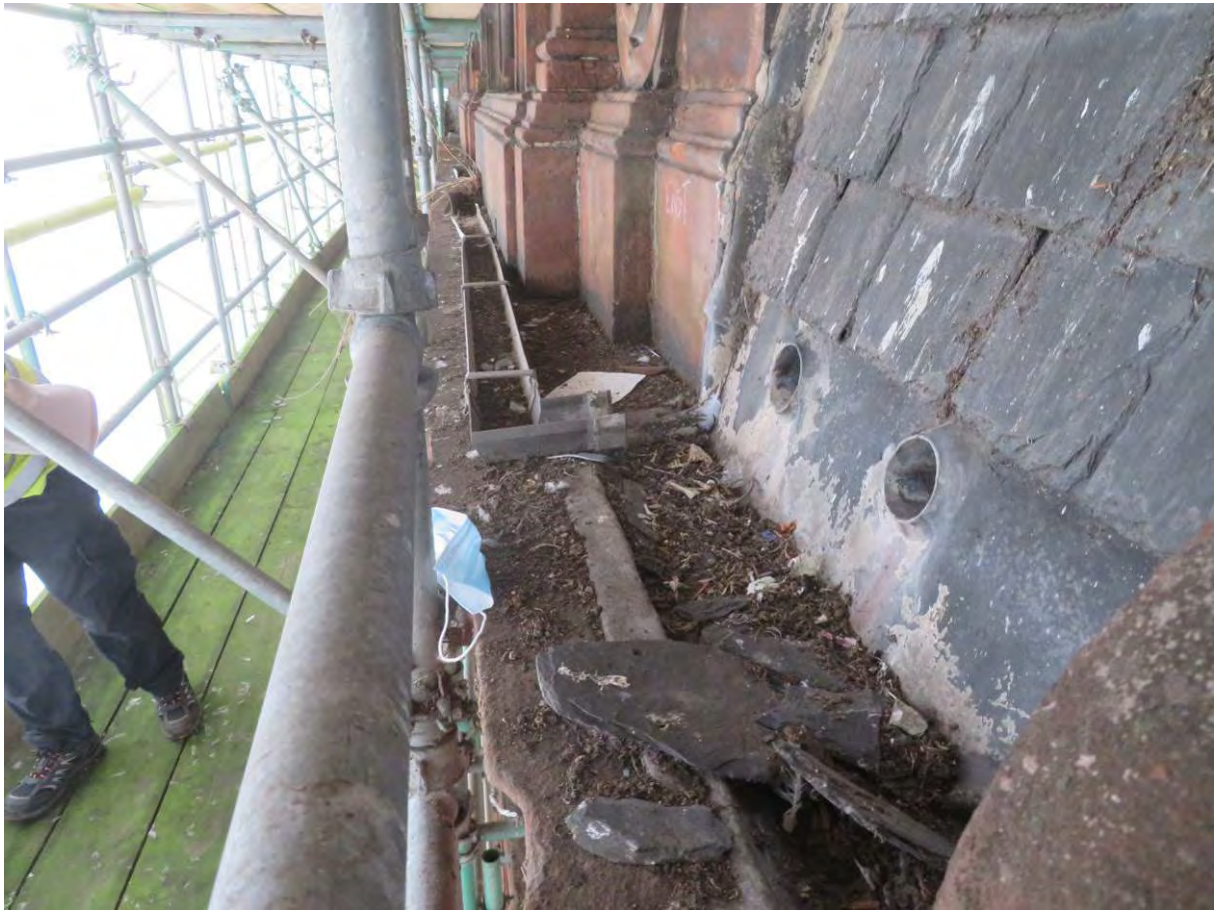
Photograph 37: Gutter amendments

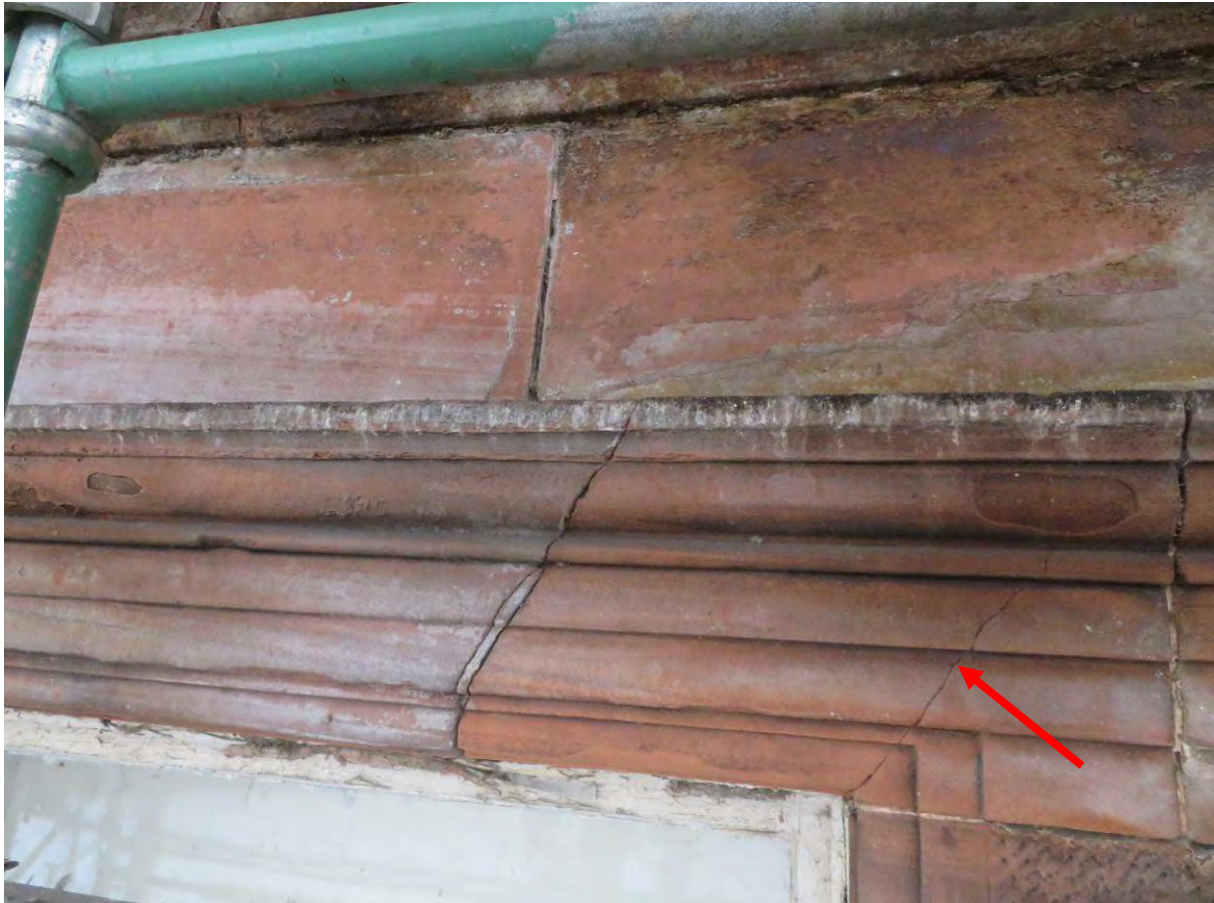
Photograph 38: Fracture to window head

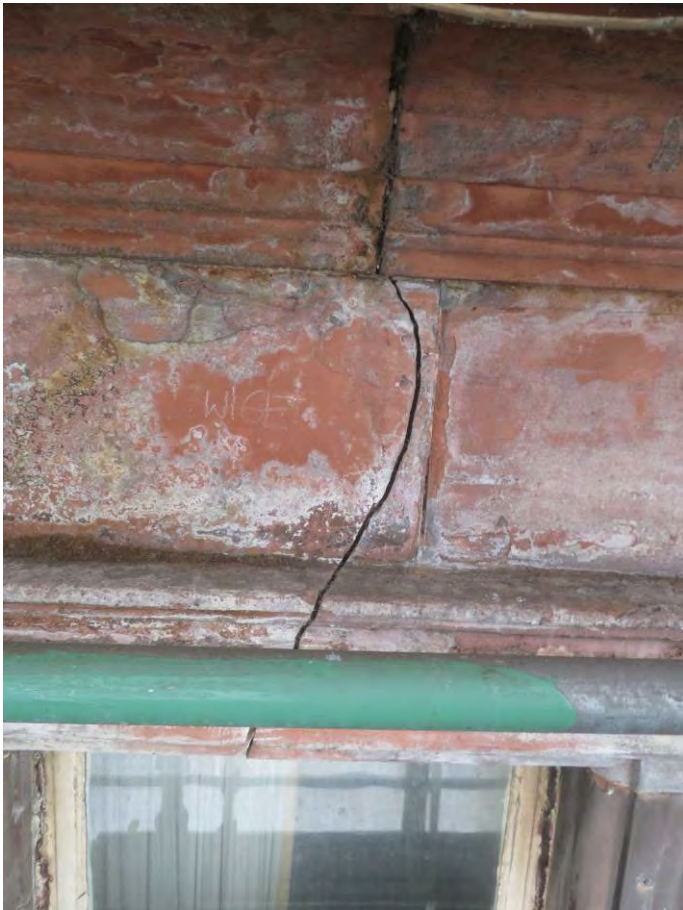
Photograph 39: Fracture to window head

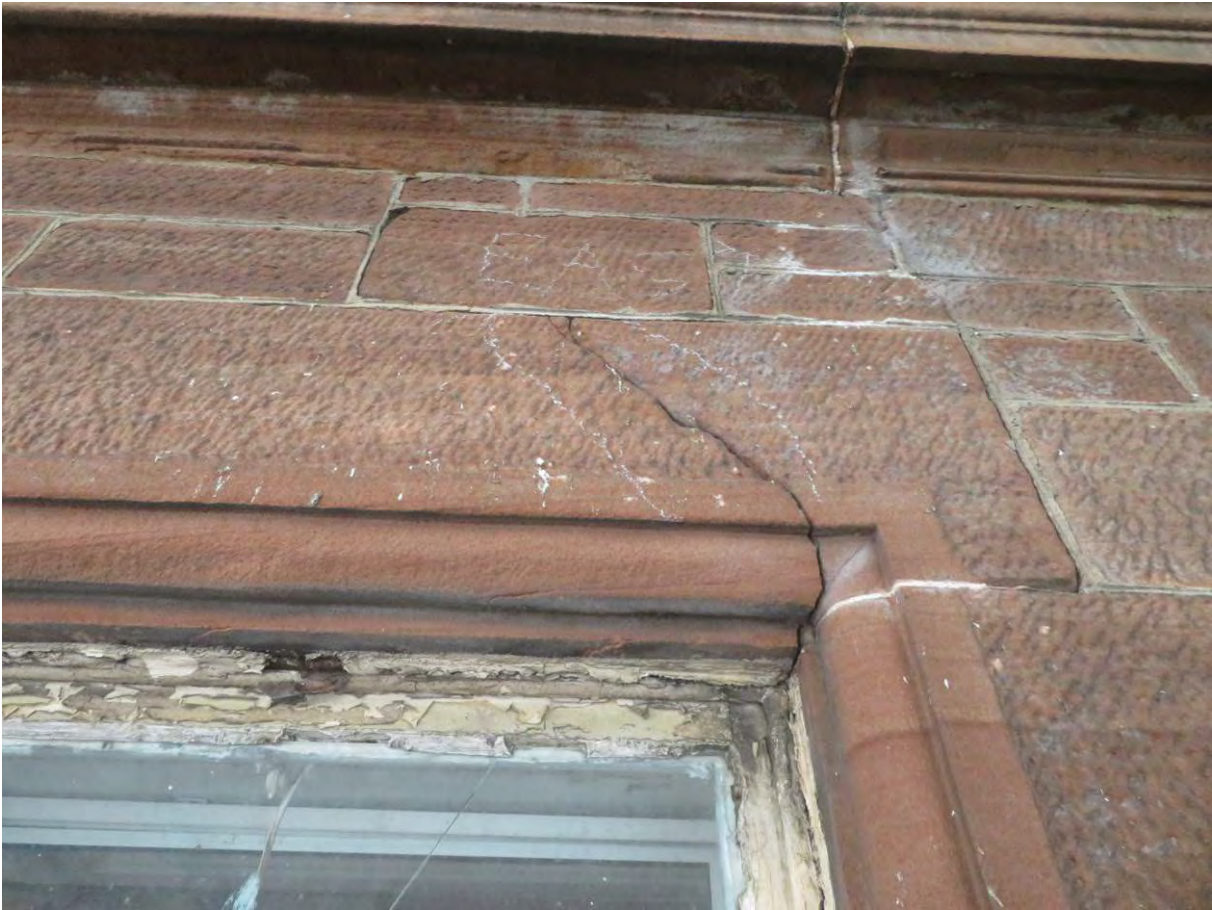
Photograph 40: Fracture to window head

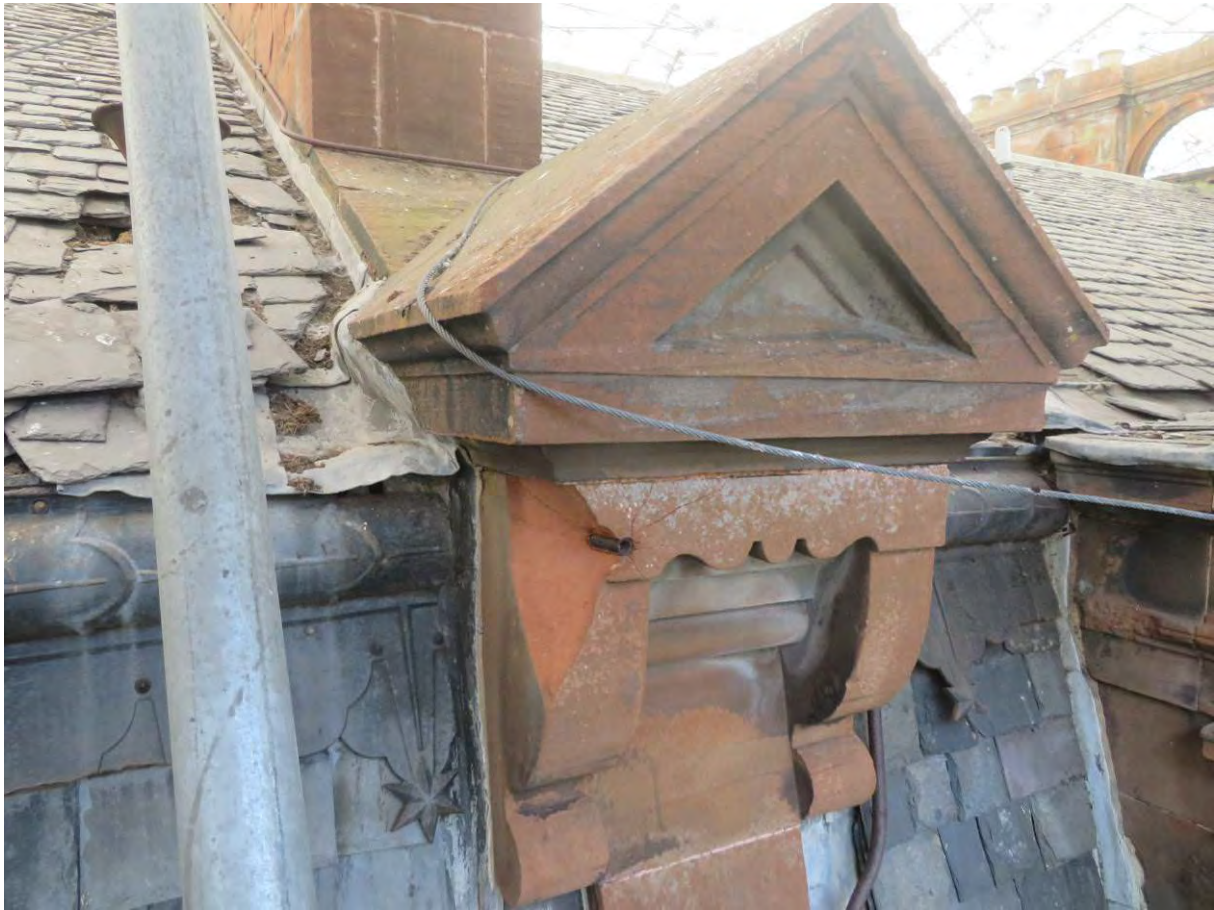
Photograph 41: Damaged stone from old scaffold fixing

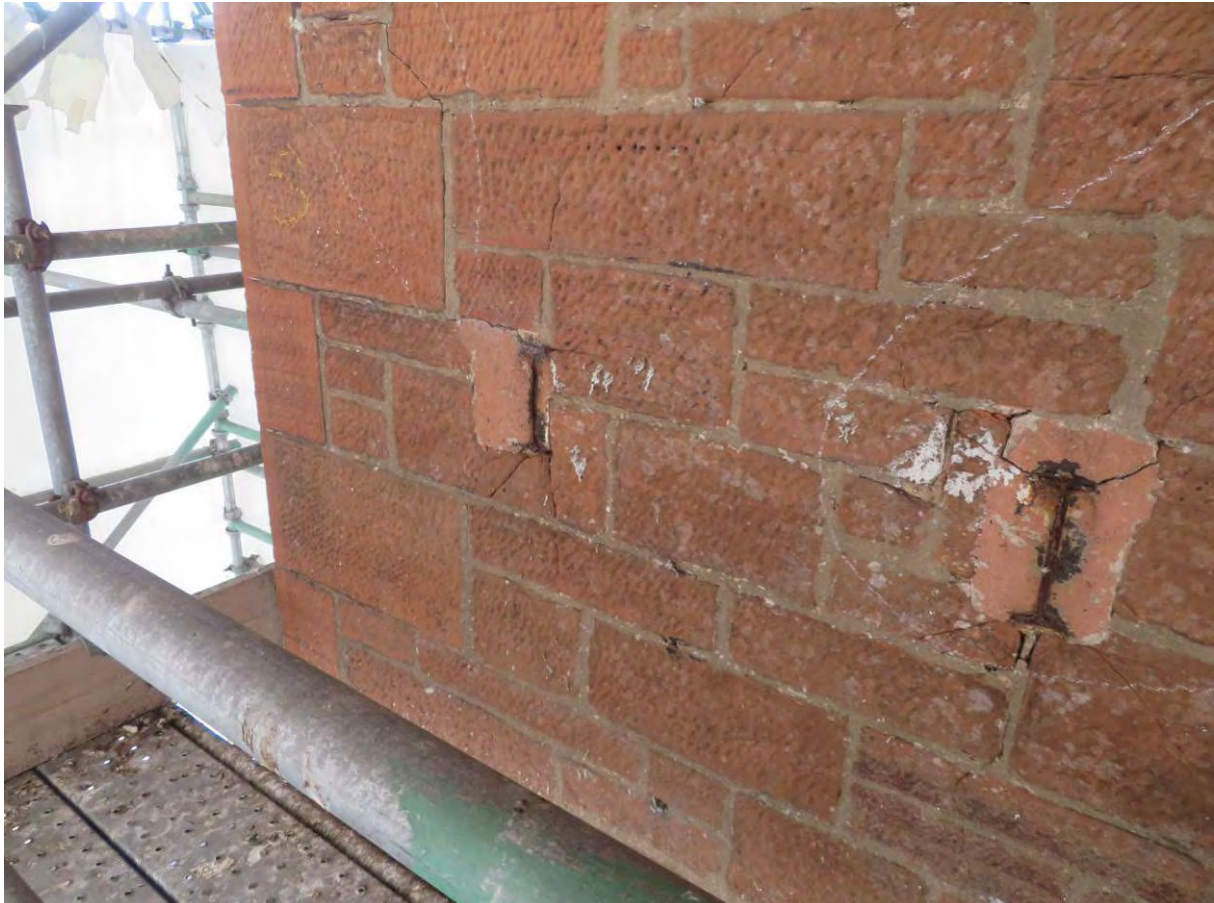
Photograph 42: Steel or iron beams built in and corroding causing damage to stone

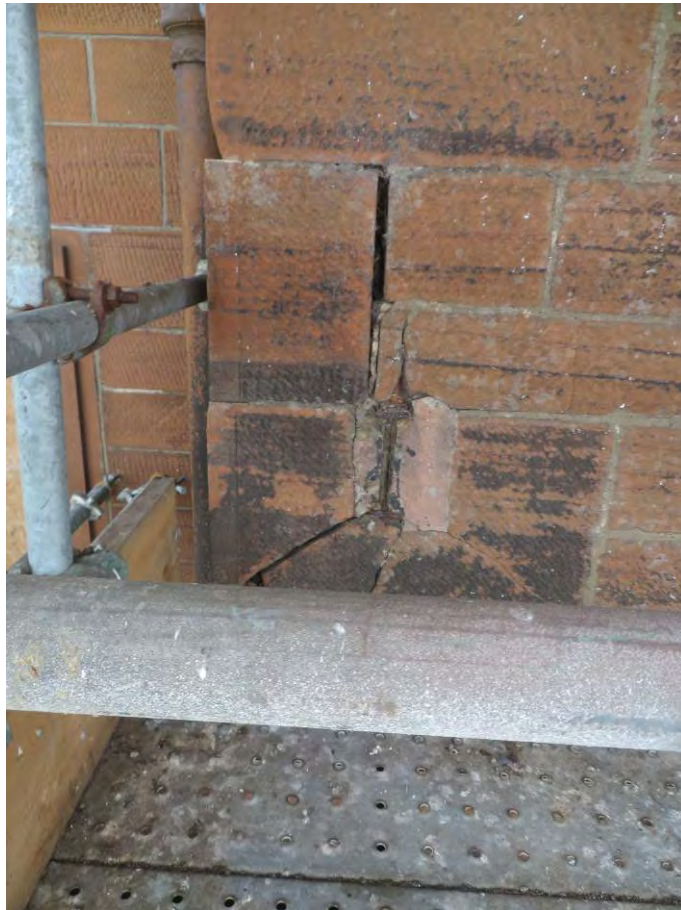
Photograph 43: Steel or iron beams built in and corroding causing damage to stone

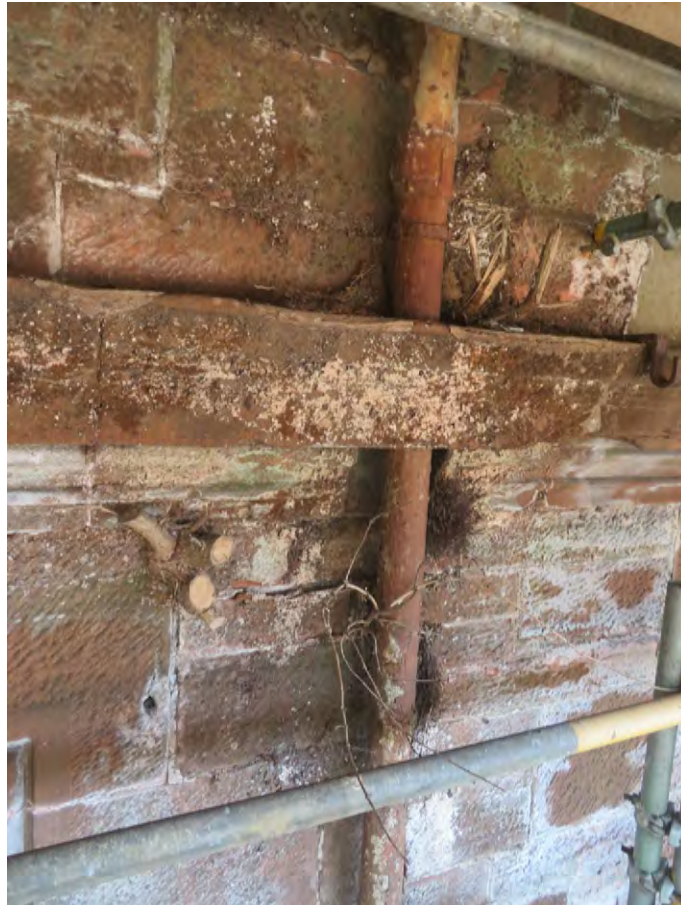
Photograph 44: Defective downpipe extending through fake 'stone hopper'

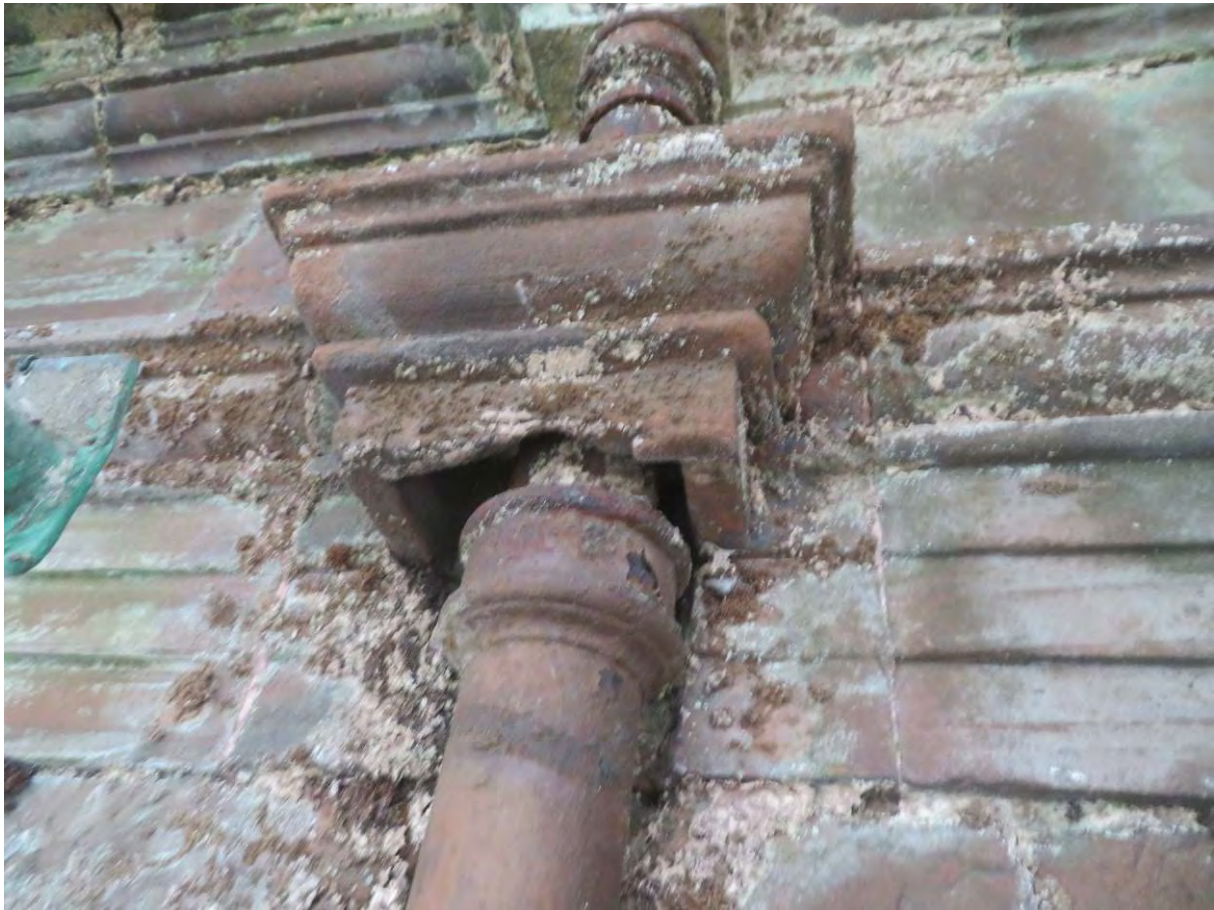
Photograph 45: Fake 'stone hopper' and defective downpipe

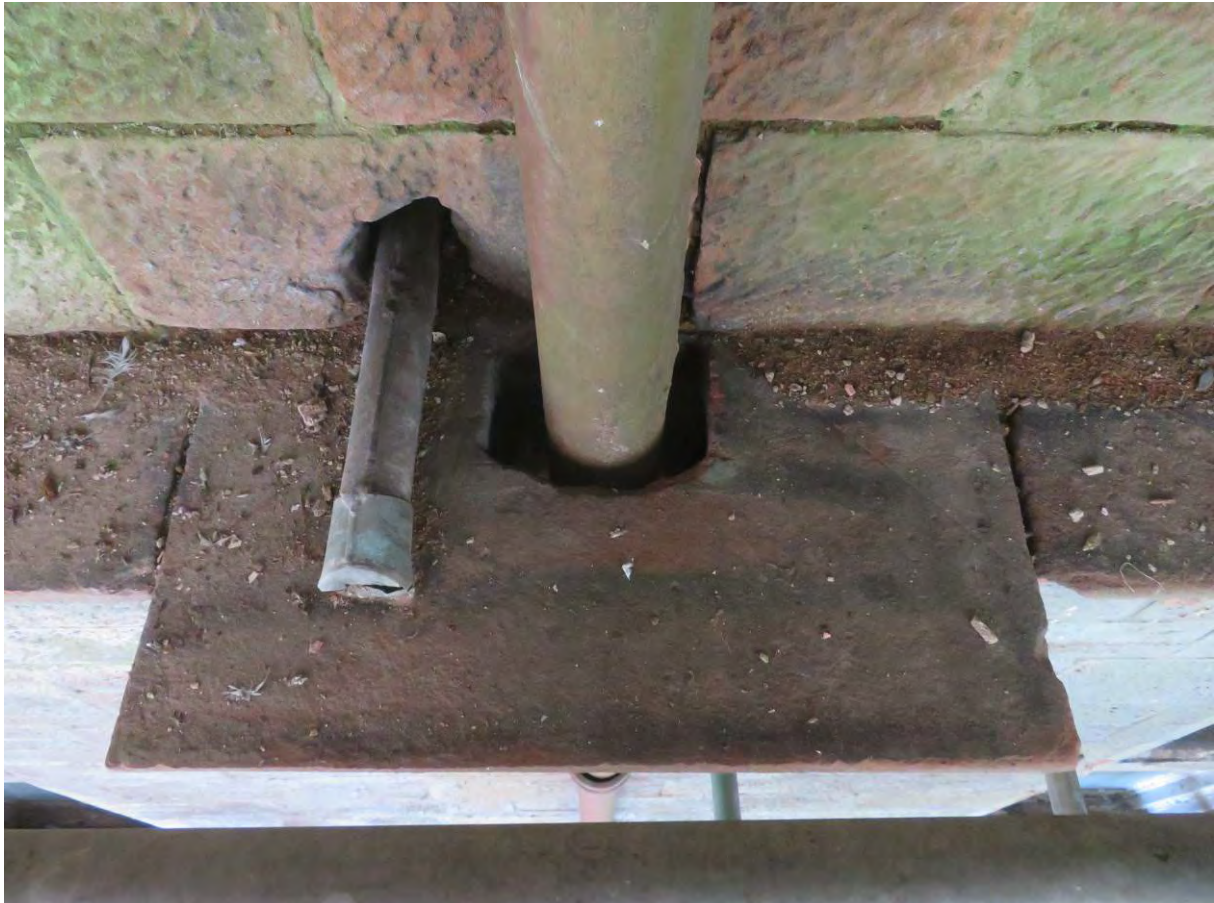
Photograph 46: Top of stone hopper

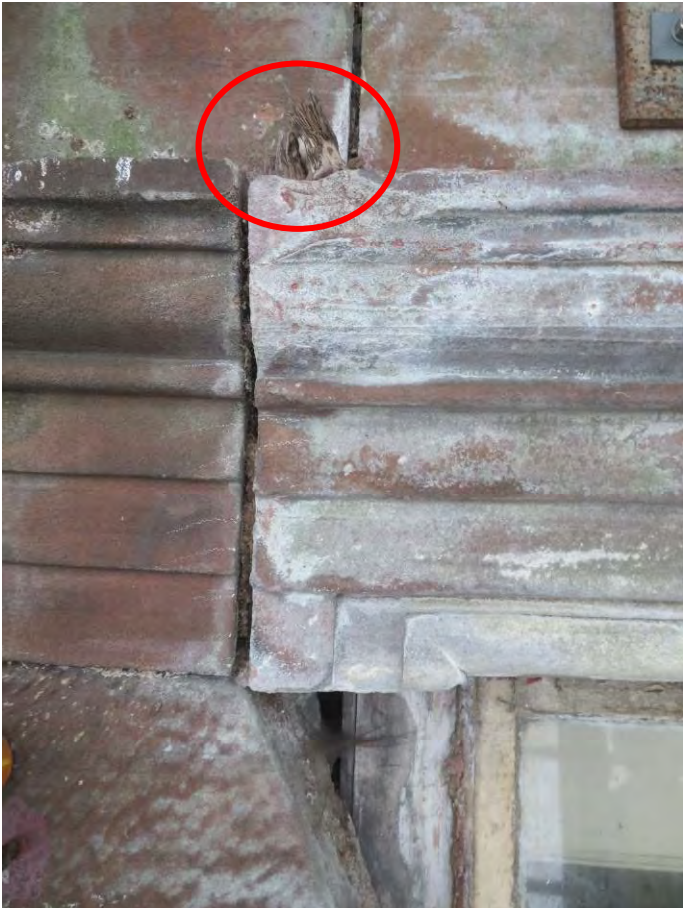
Photograph 48: Root expansion causing fracture

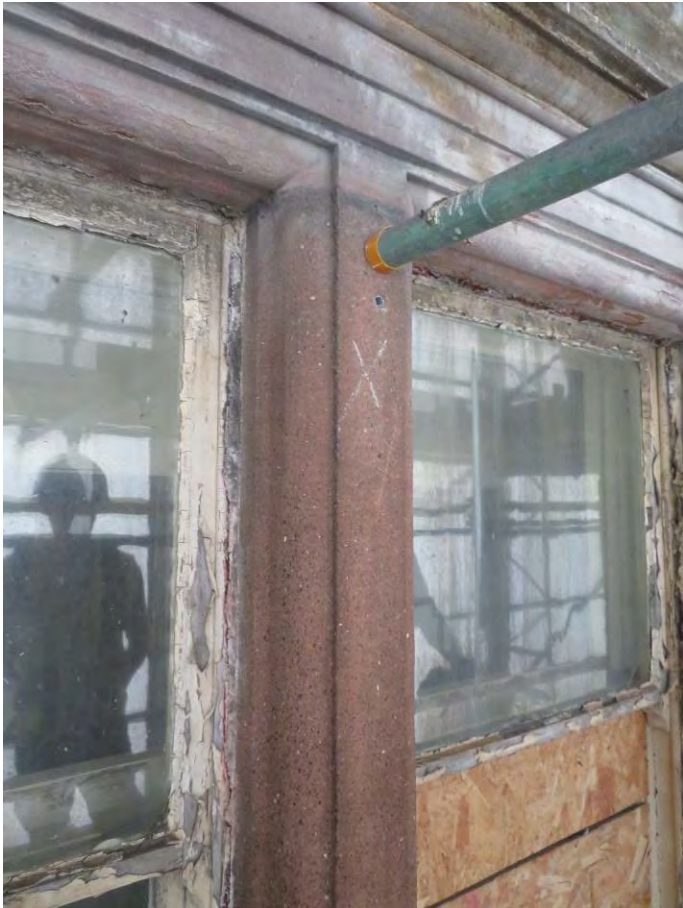
Photograph 49: Apparent coloured pre-cast concrete mullion

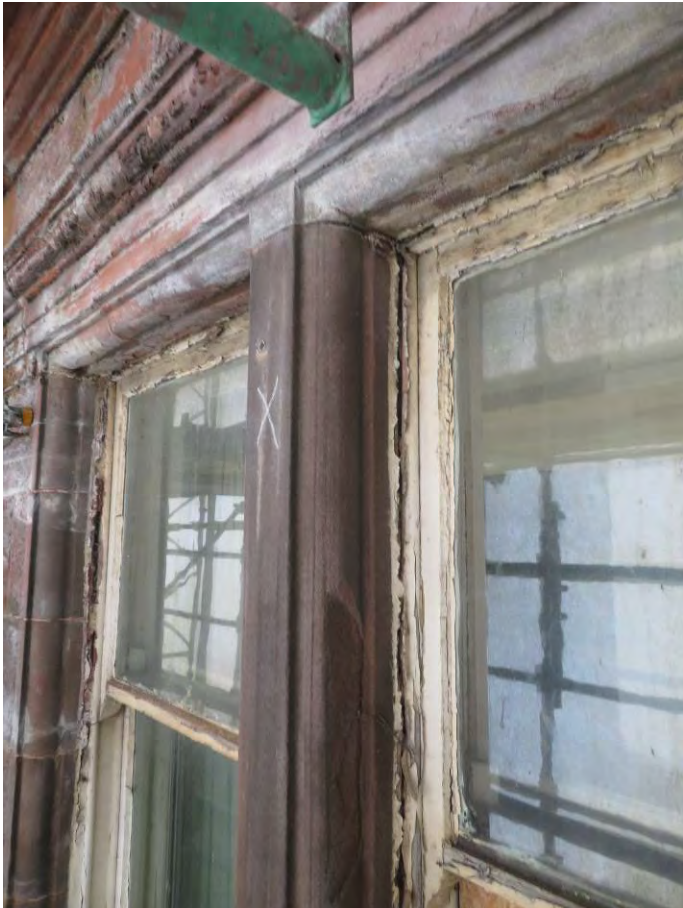
Photograph 50: Failed face of stone mullion

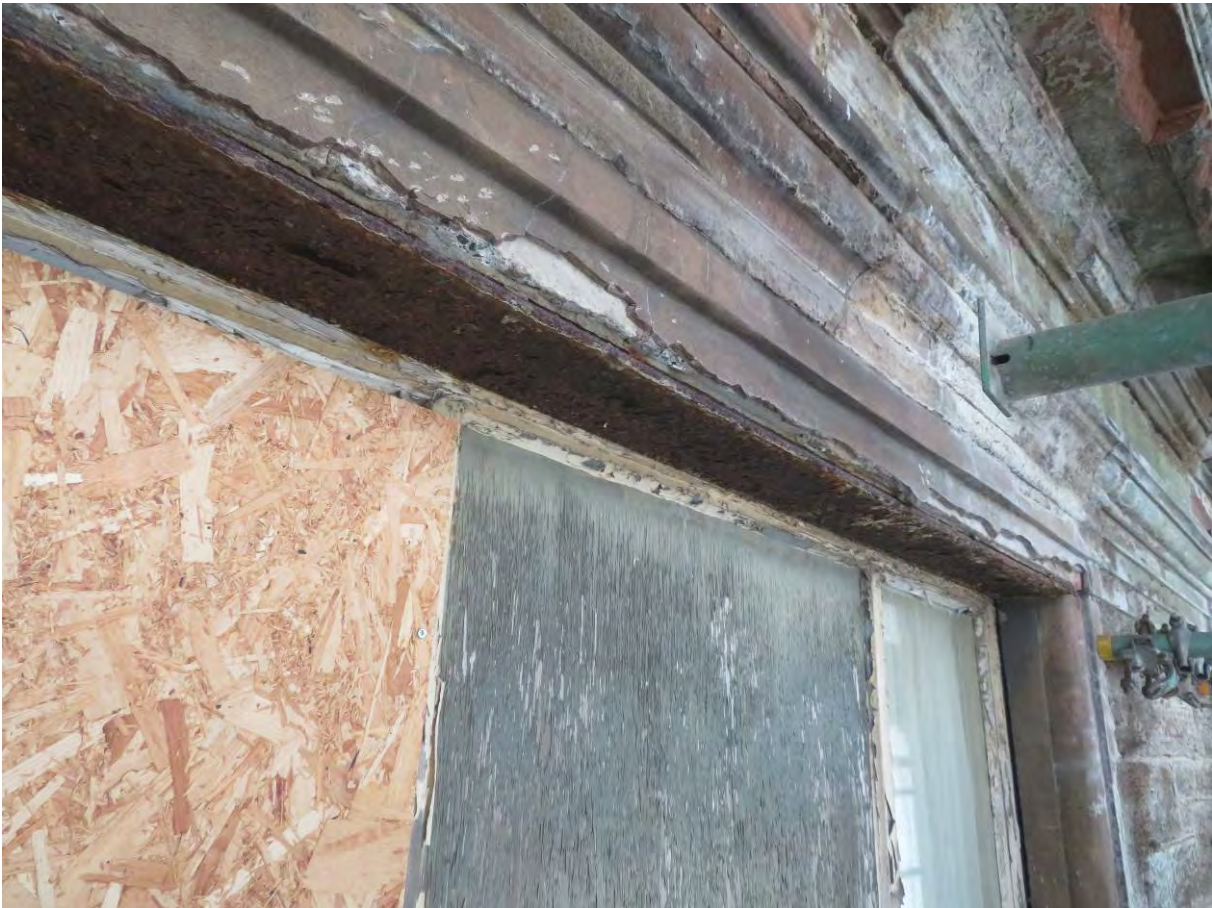
Photograph 51: Steel plate flat bar over window
