The Morton Partnership
Structural Engineers

Registered in England No. 2727193

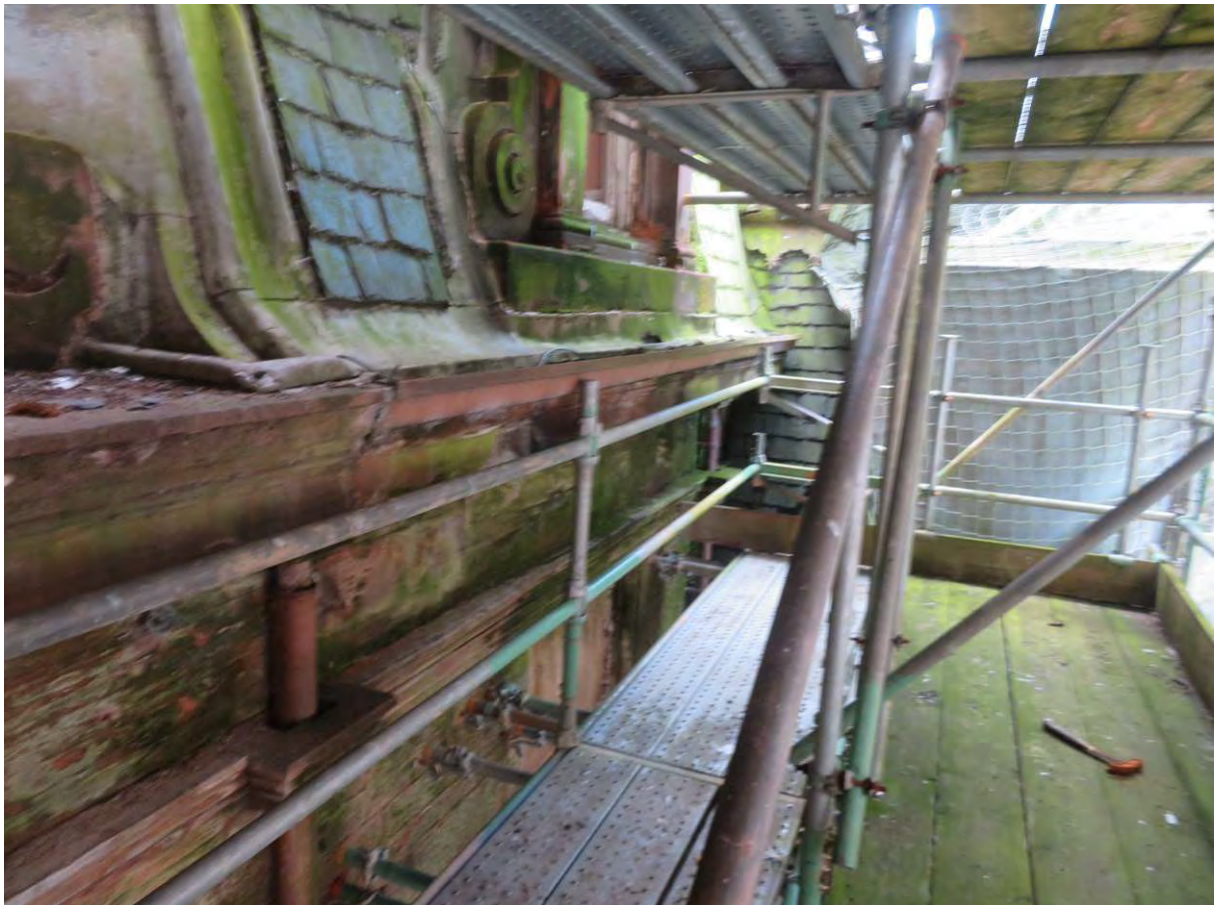
Photograph 54: Significant moisture to west end of north elevation

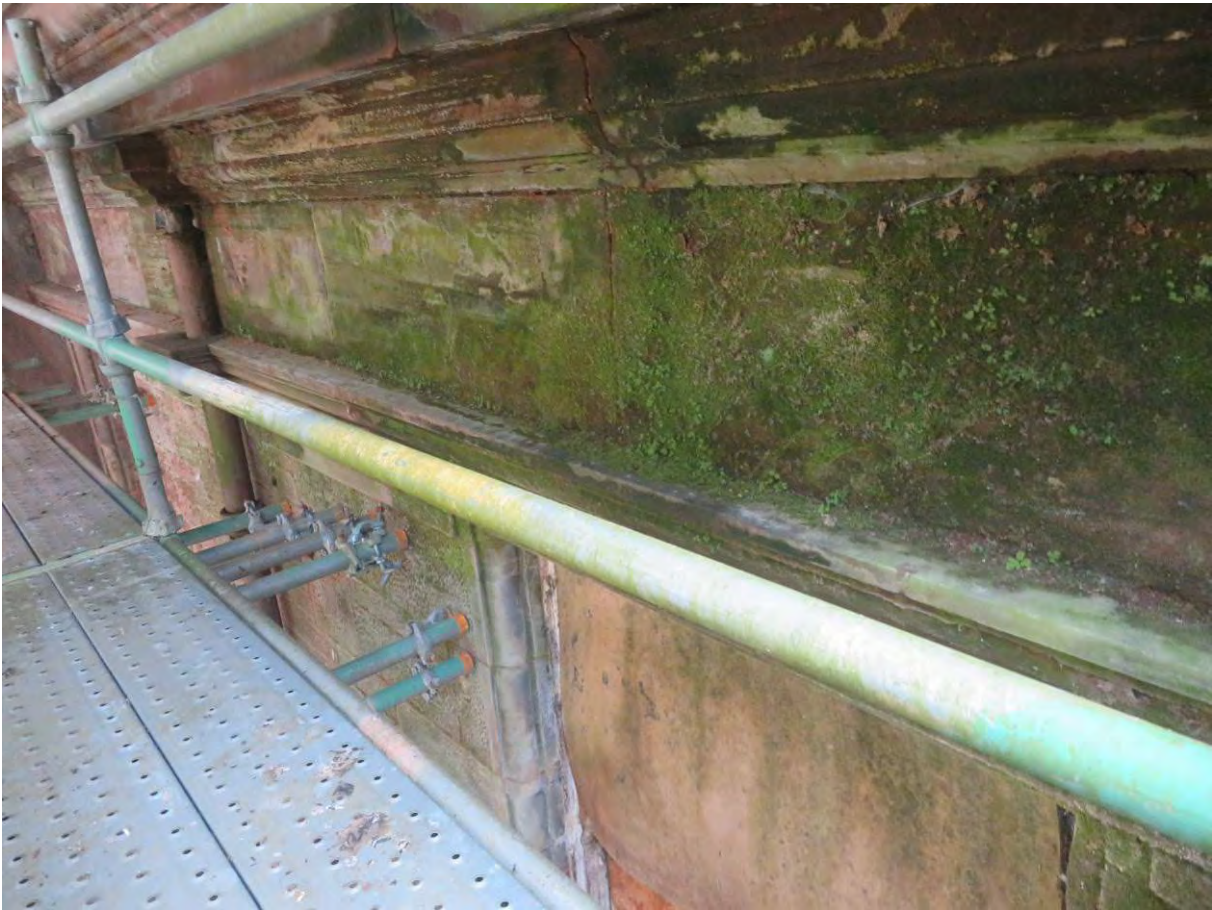
Photograph 55: Significant moisture to west end of north elevation

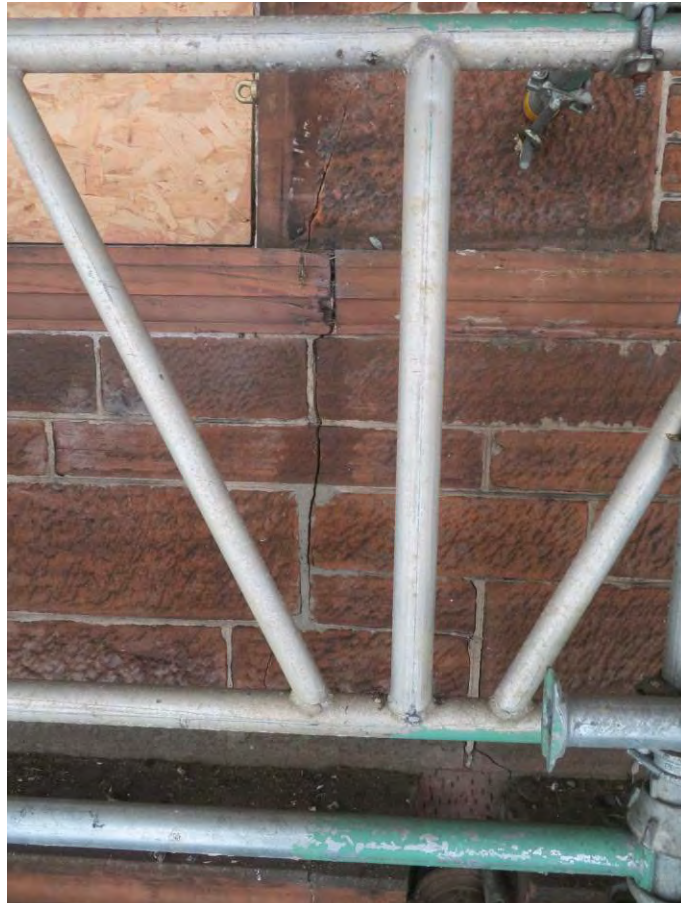
Photograph 56: Movement cracks to north east corner

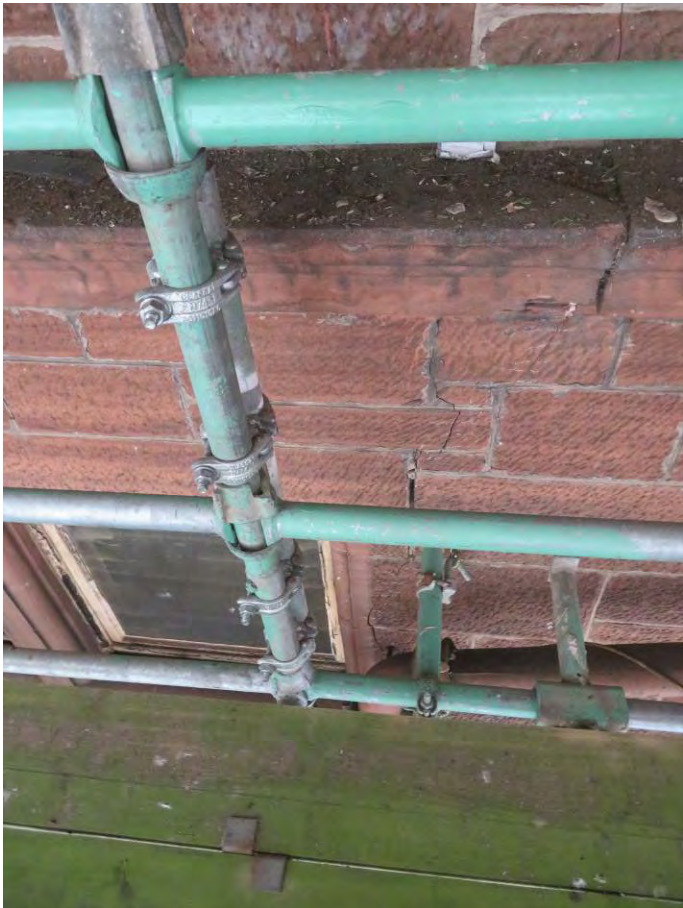
Photograph 57: Movement cracks to north east corner

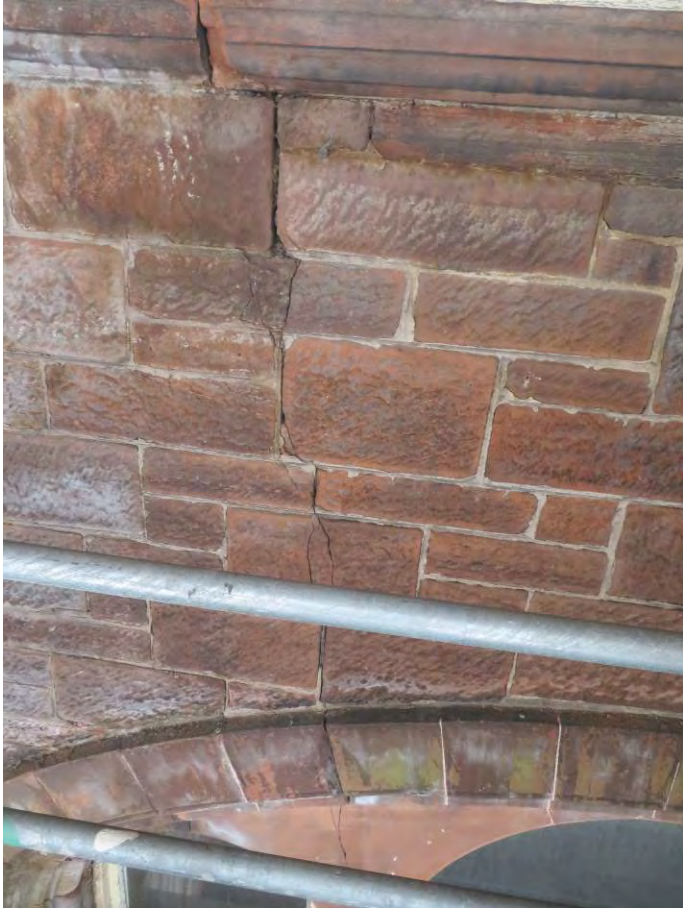
Photograph 58: Movement cracks to north east corner

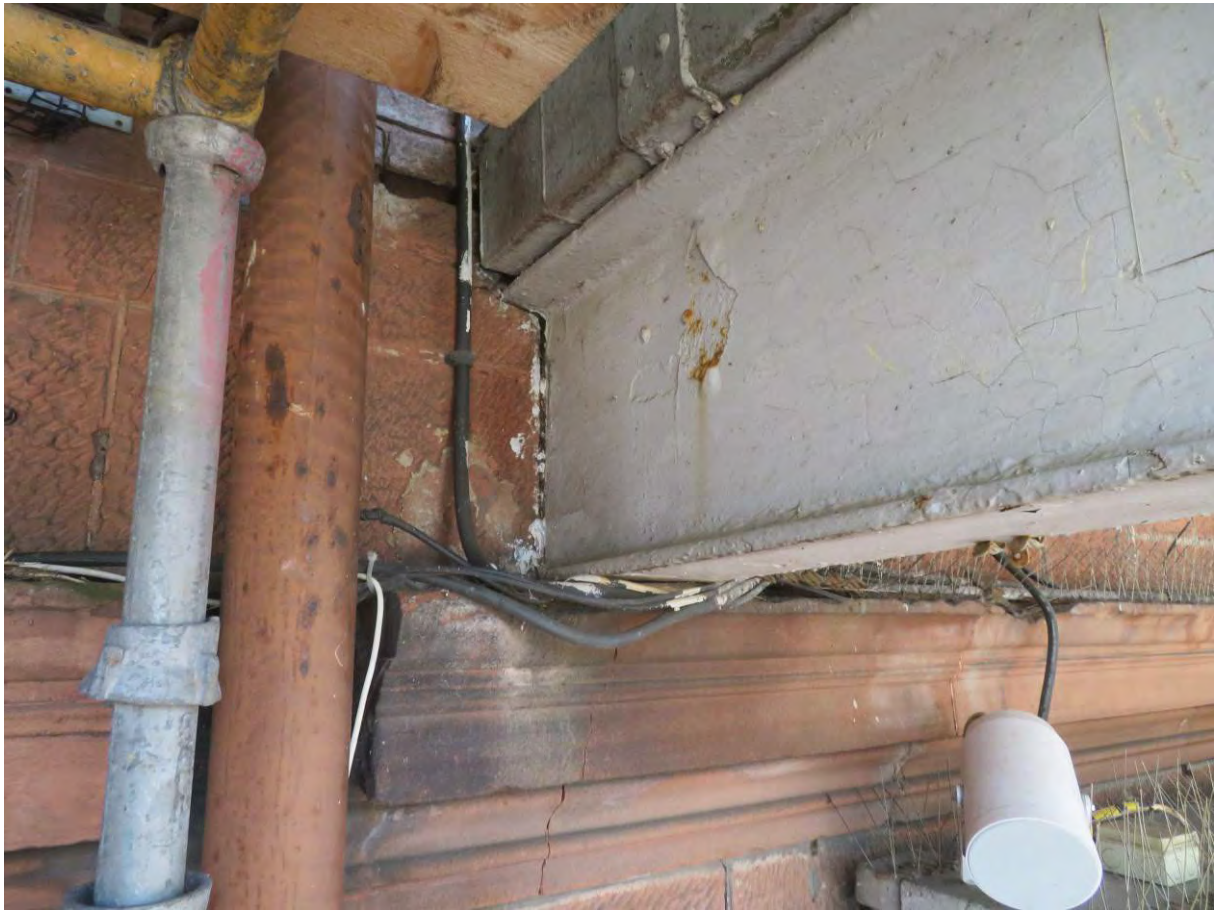
Photograph 59: Main station beam with apparent corrosion jacking to end

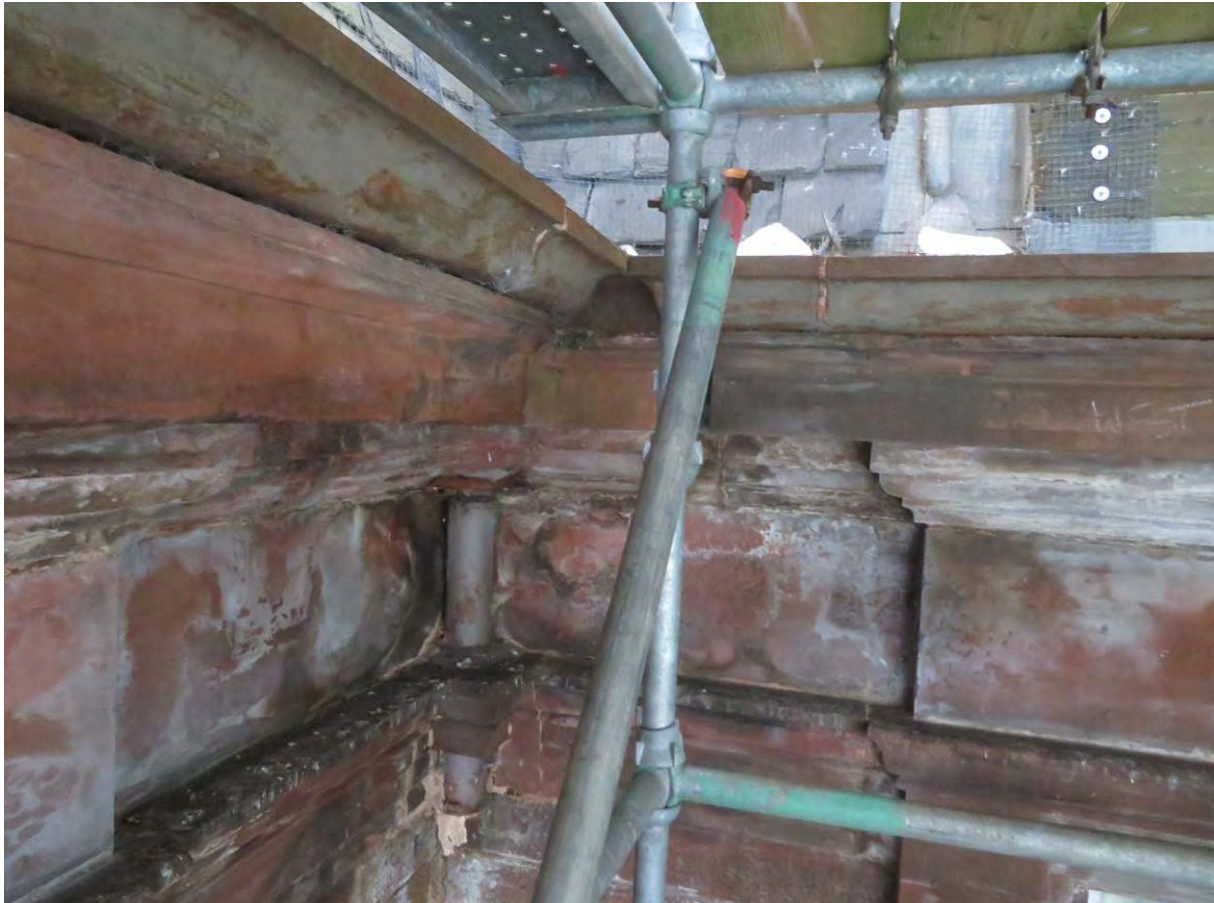
Photograph 60: North end of west elevation at junction with dog-leg

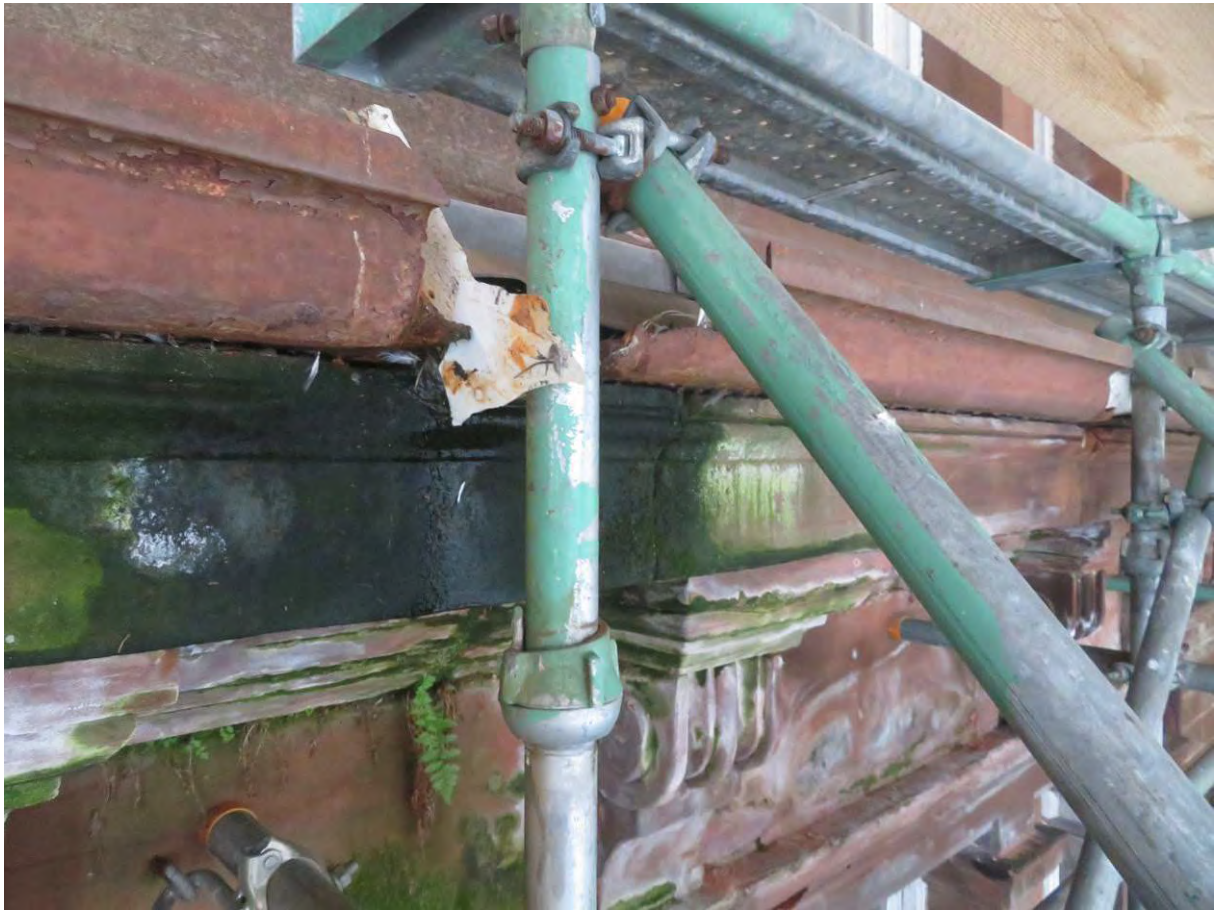
Photograph 61: Significant damp and current water damage

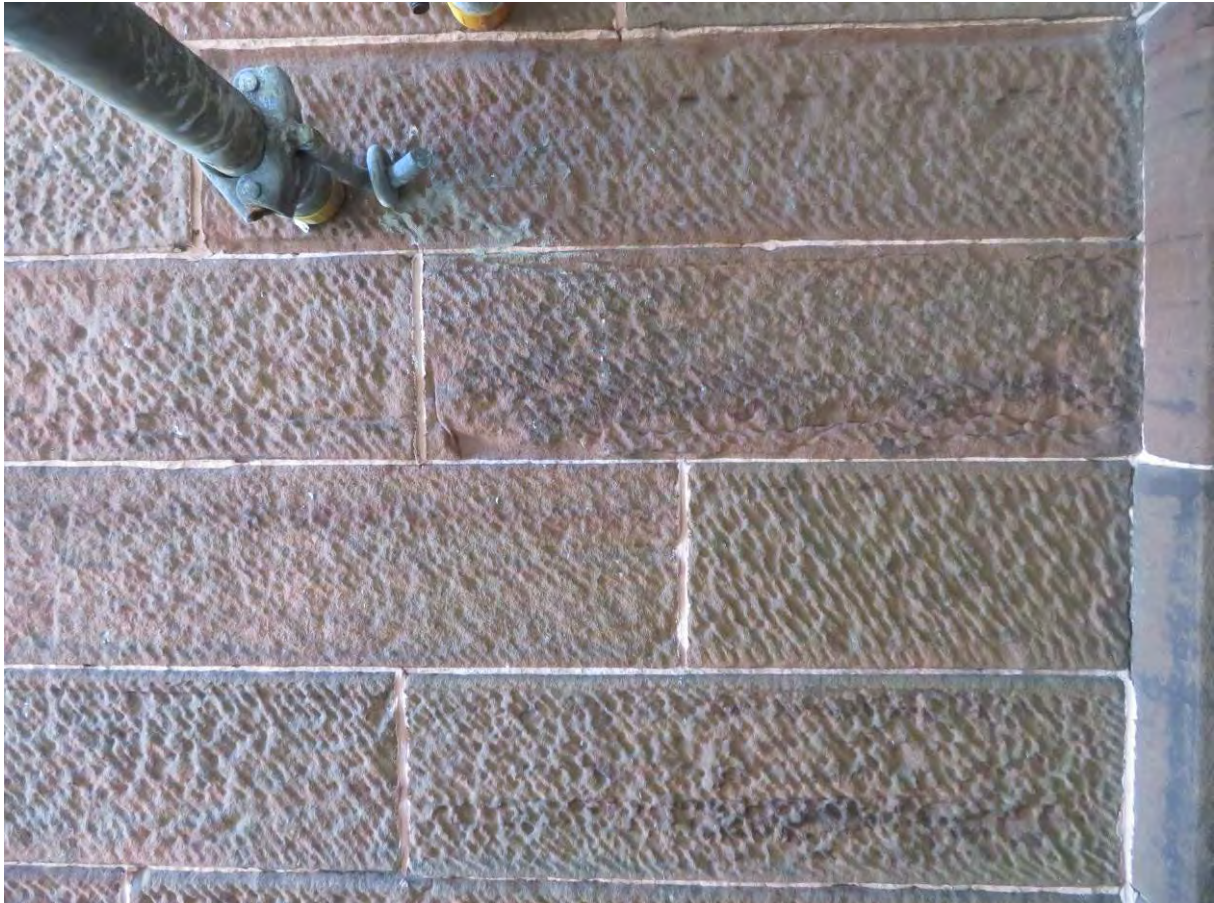
Photograph 62: Tight and possibly lime putty joints to public facing elevations

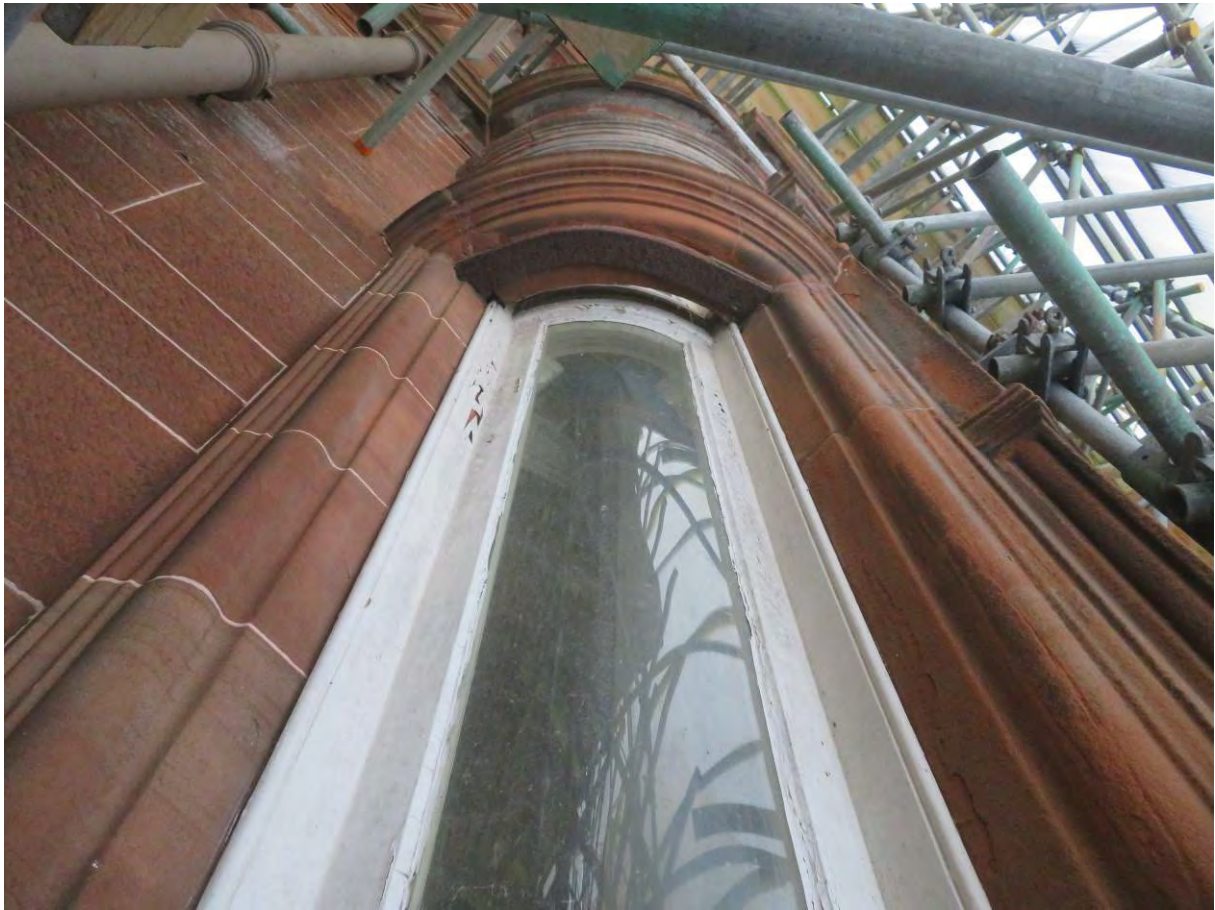
Photograph 65: Steel or iron plate below fractured lintel

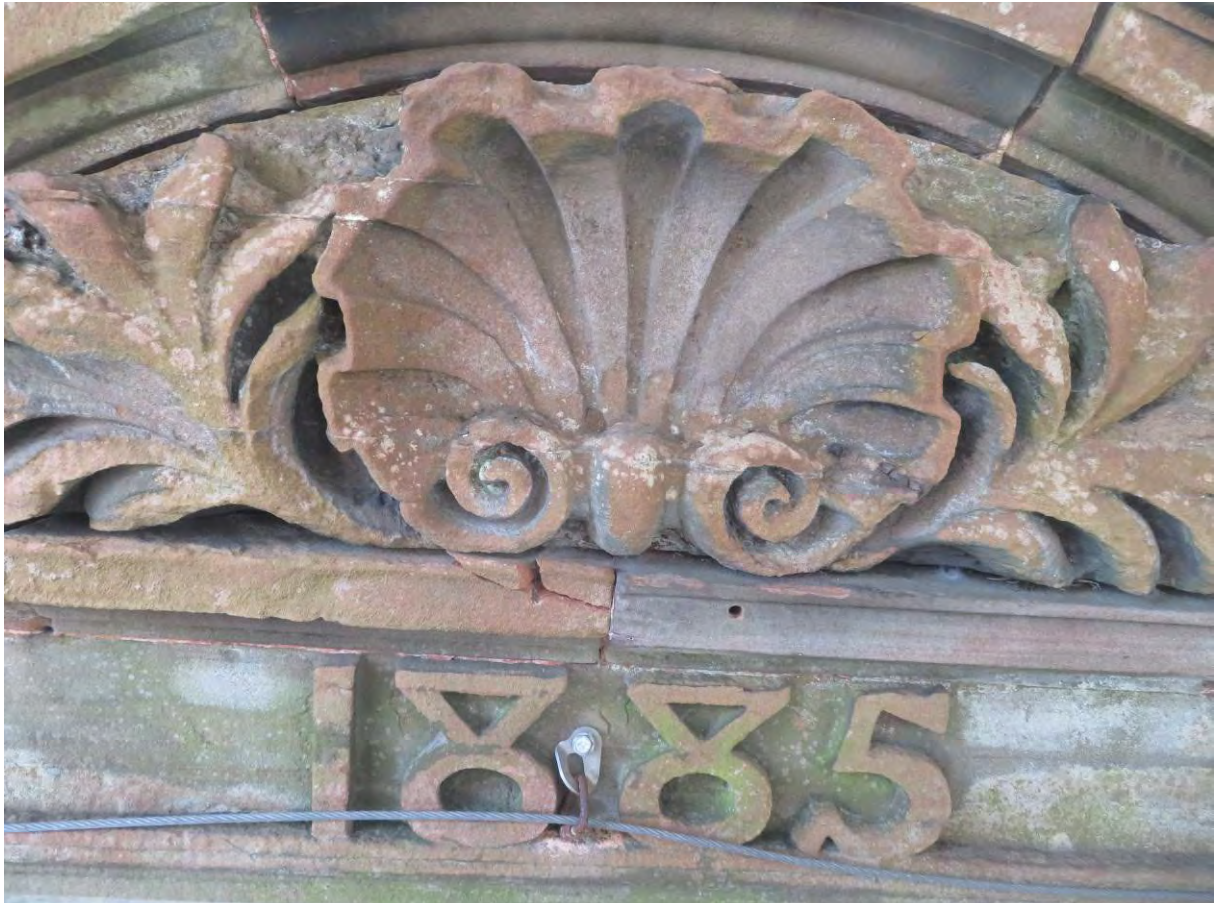
Photograph 66: Architectural detailing

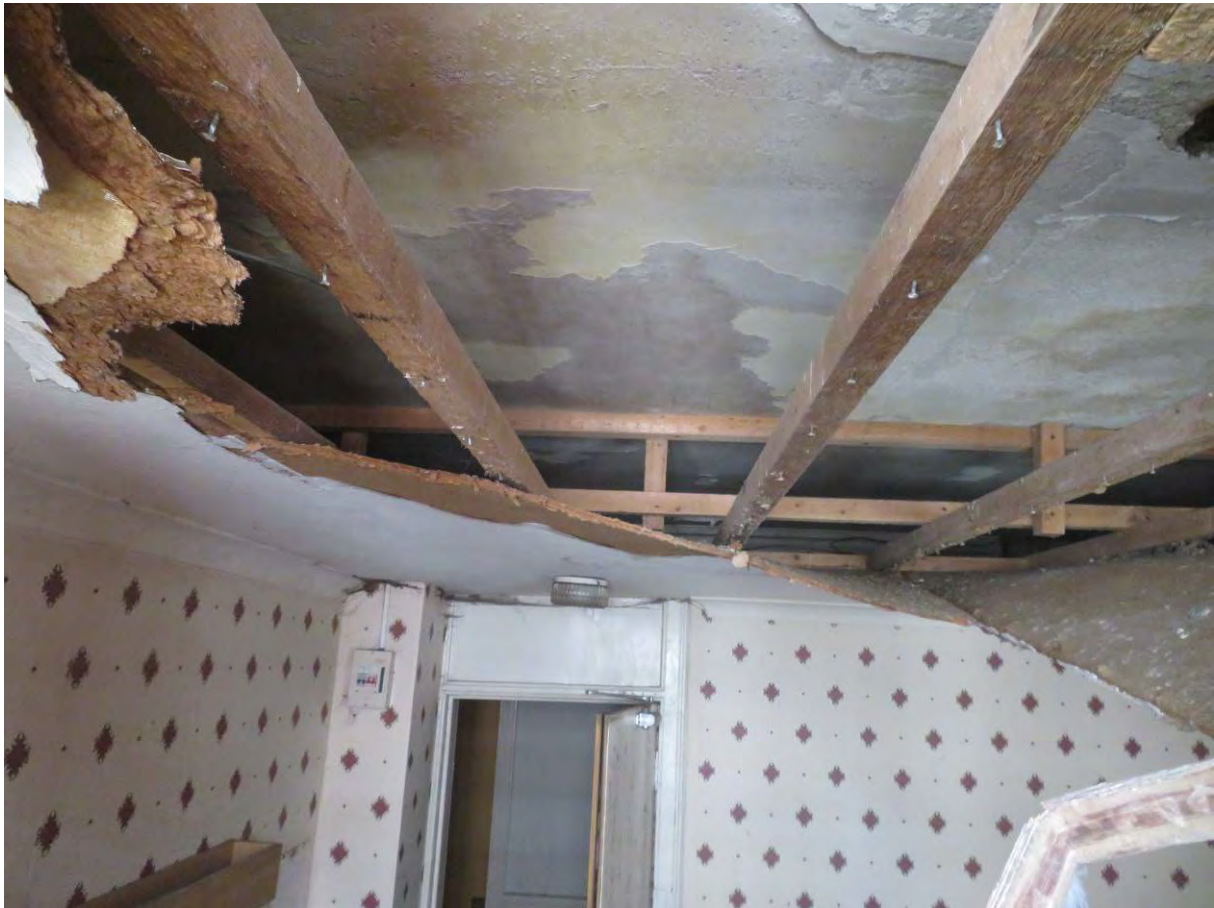
Photograph 75: Suspended ceiling below earlier ceiling above and in reasonable condition

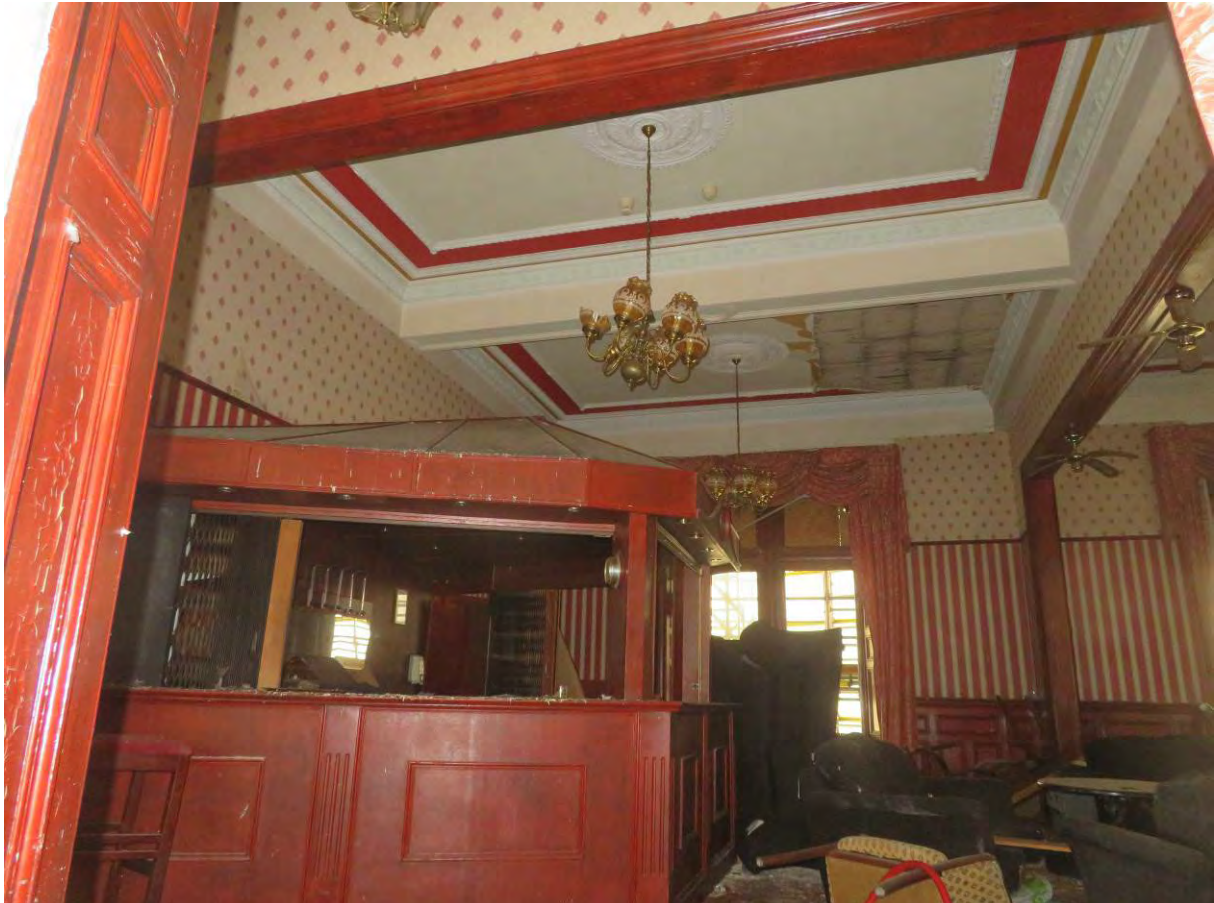
Photograph 76: Principal room with ceiling in reasonable condition but some plaster loss

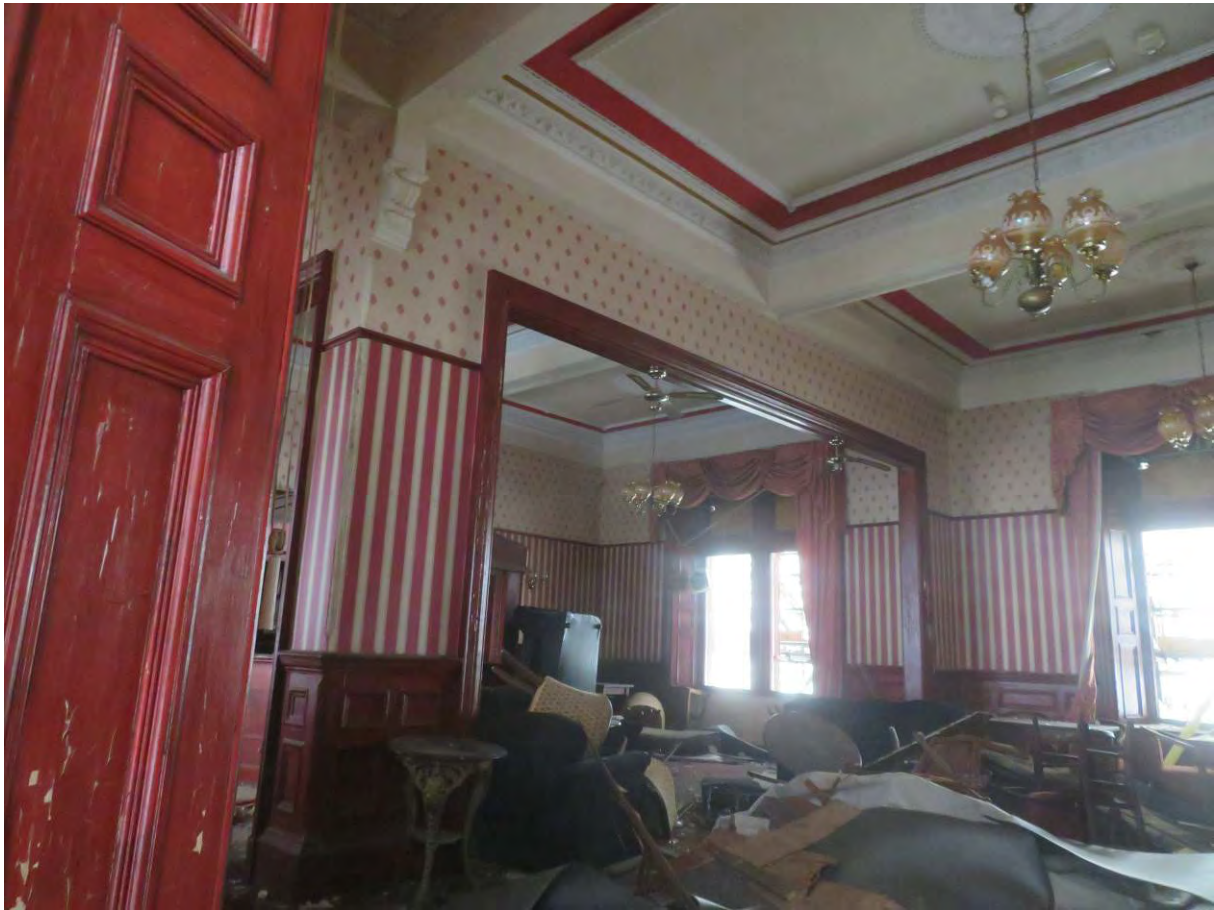
Photograph 77: Principal room with ceiling in reasonable condition

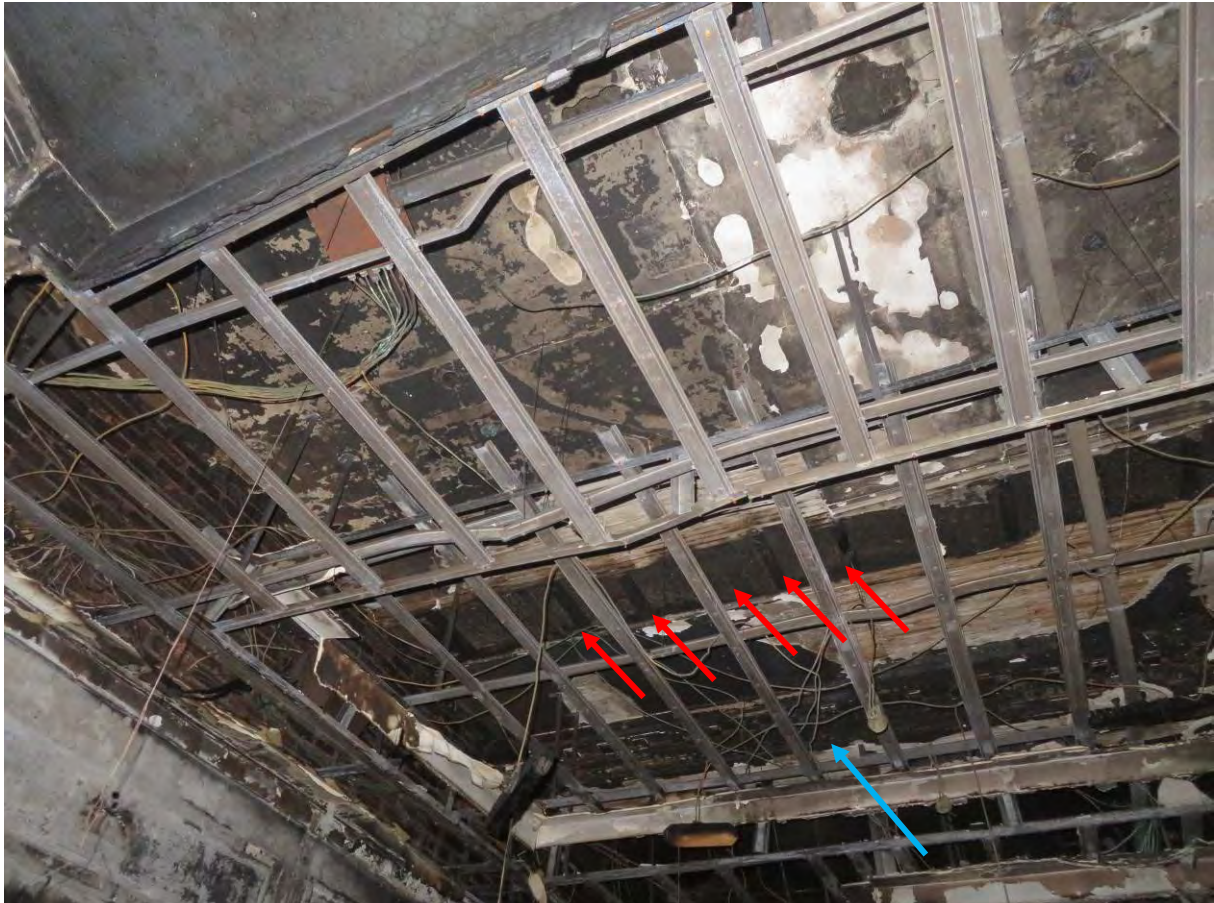
Photograph 78: Iron/steel beams (red) and concrete jack arches and main beams (blue)

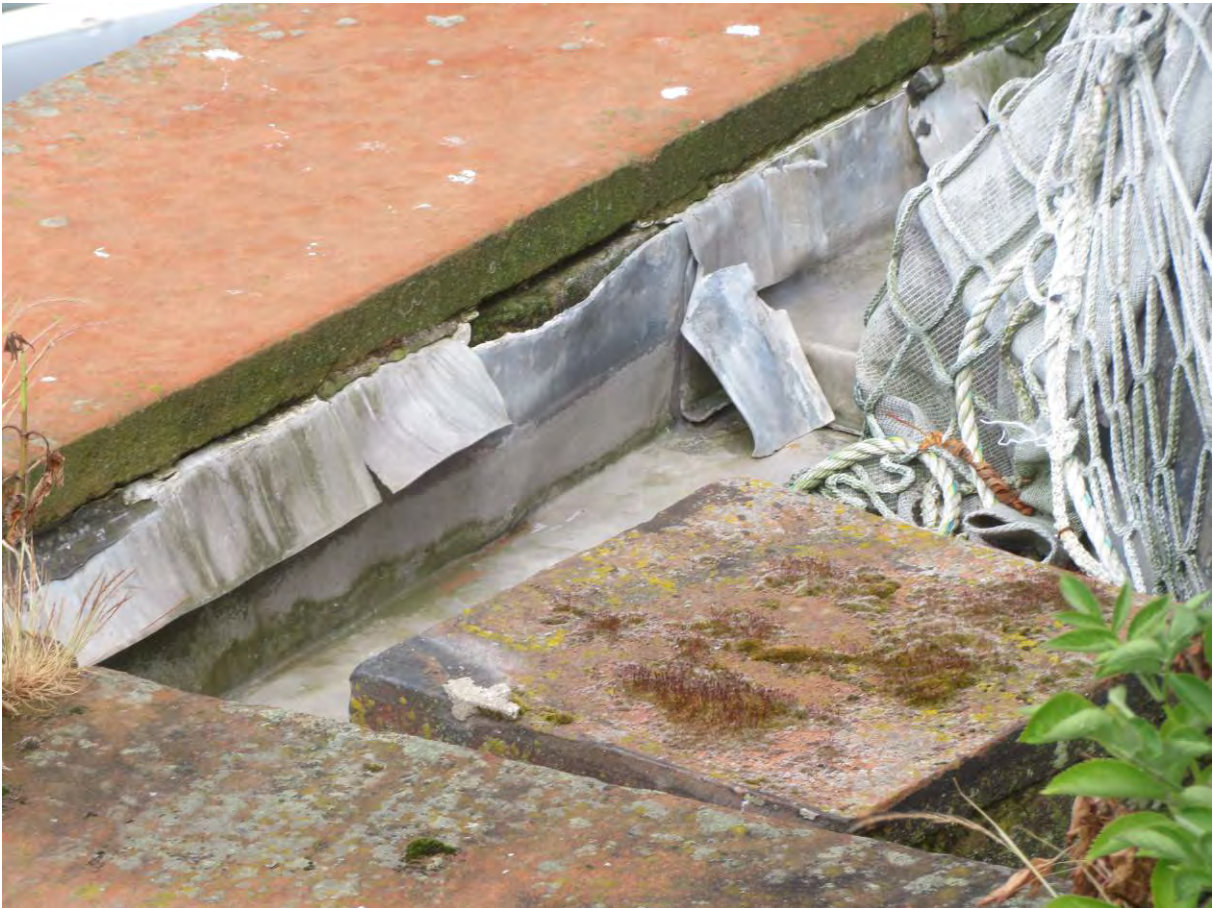
Photograph 83: Loose flashings to tower roof

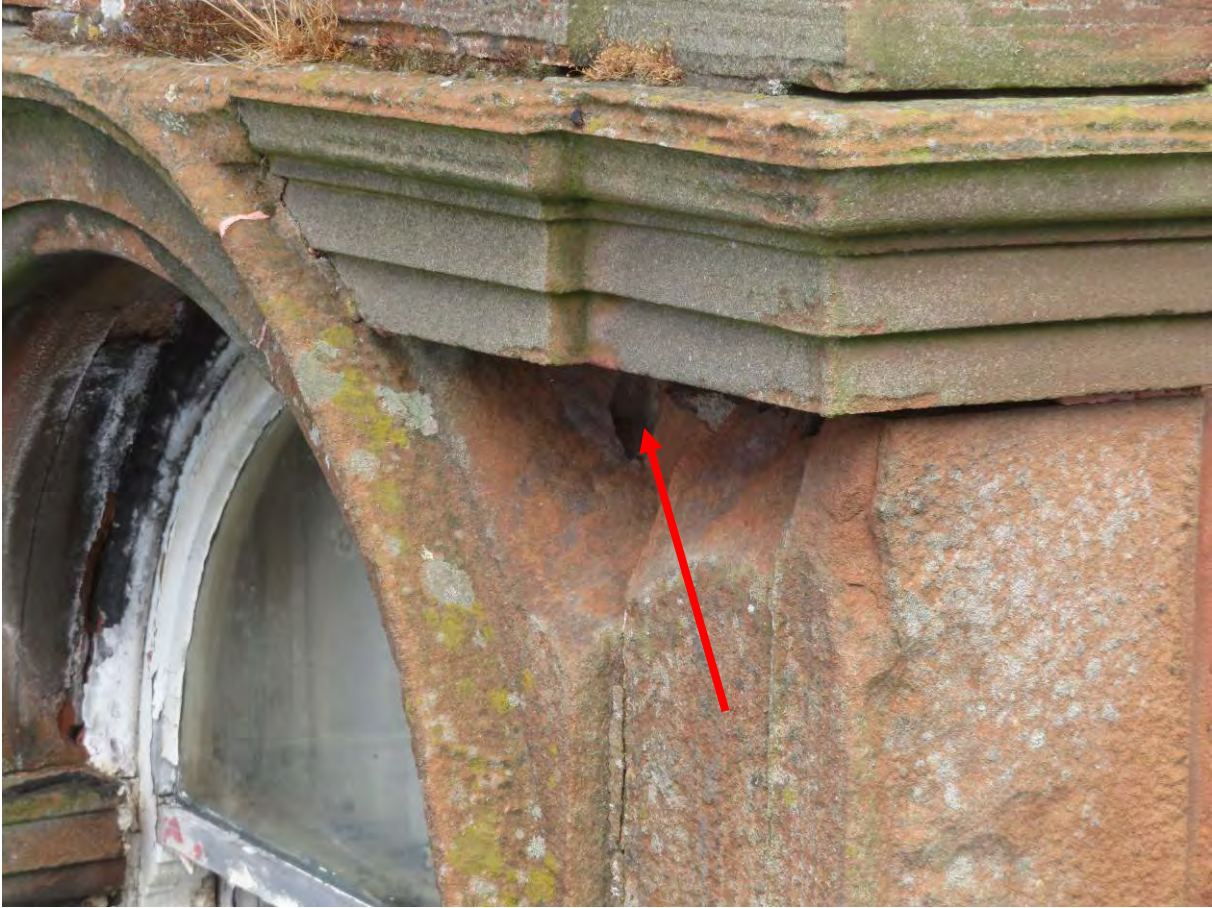
Photograph 84: Potential corroding fixing position

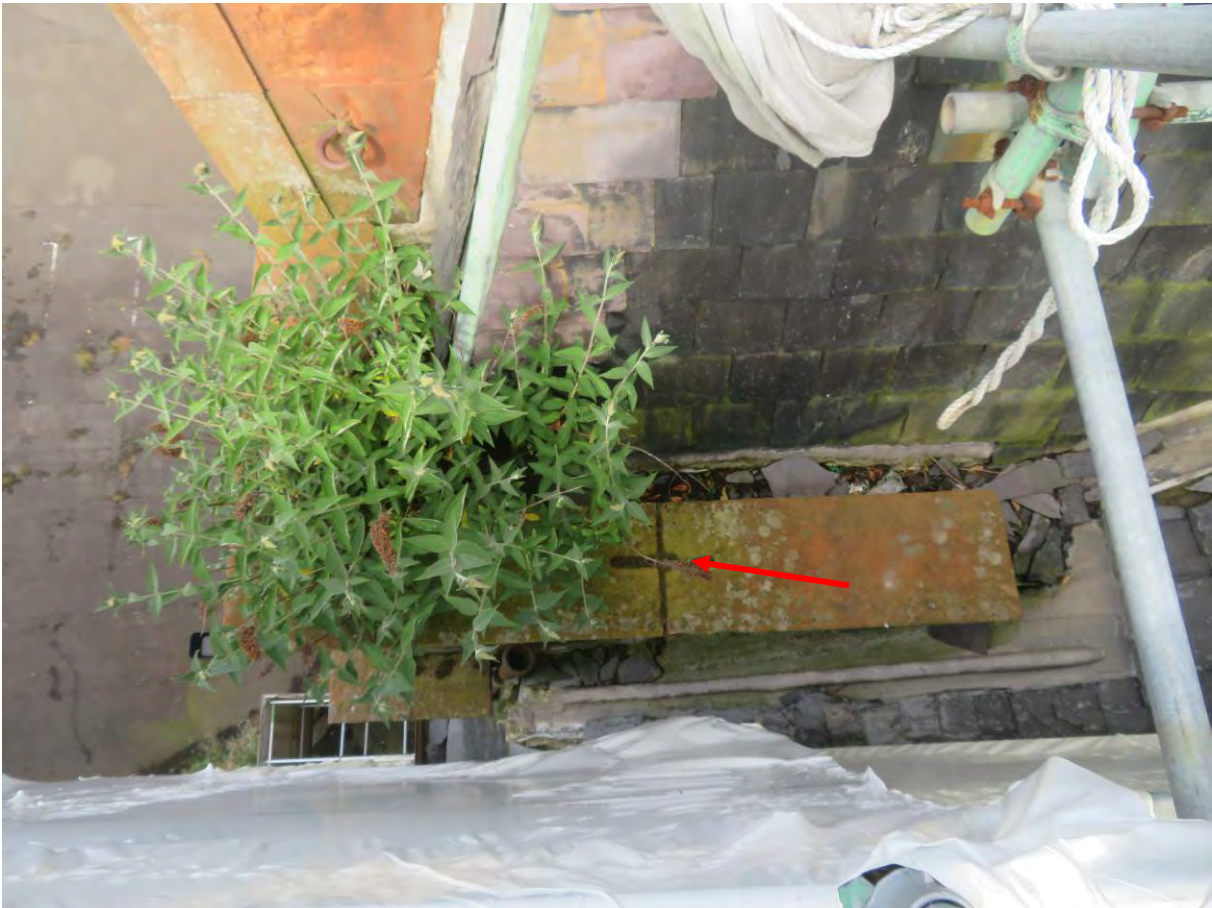
Photograph 85: Cramp to copings

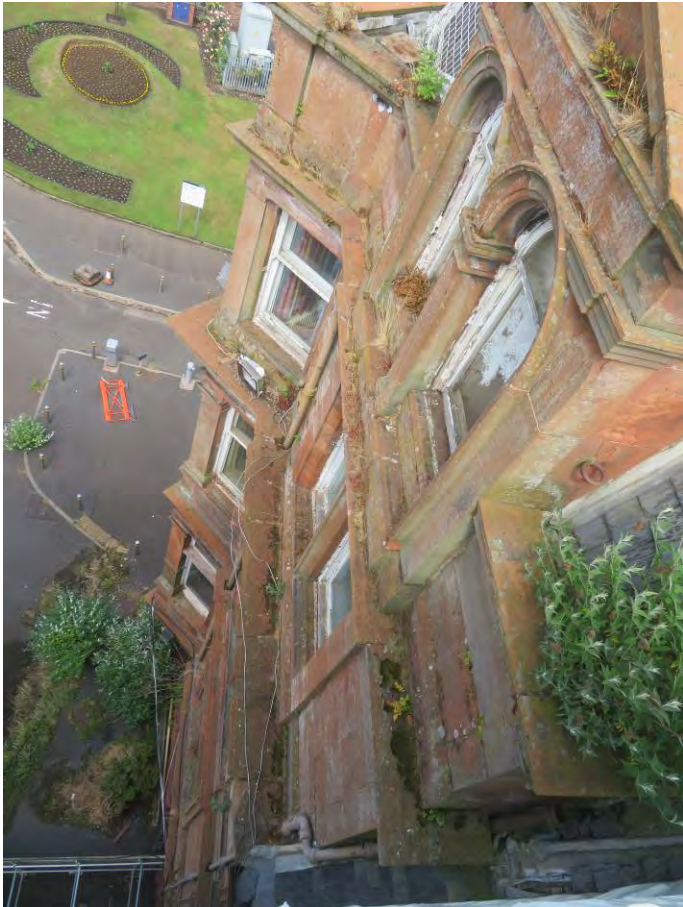
Photograph 86: Windows to tower in relatively poor condition

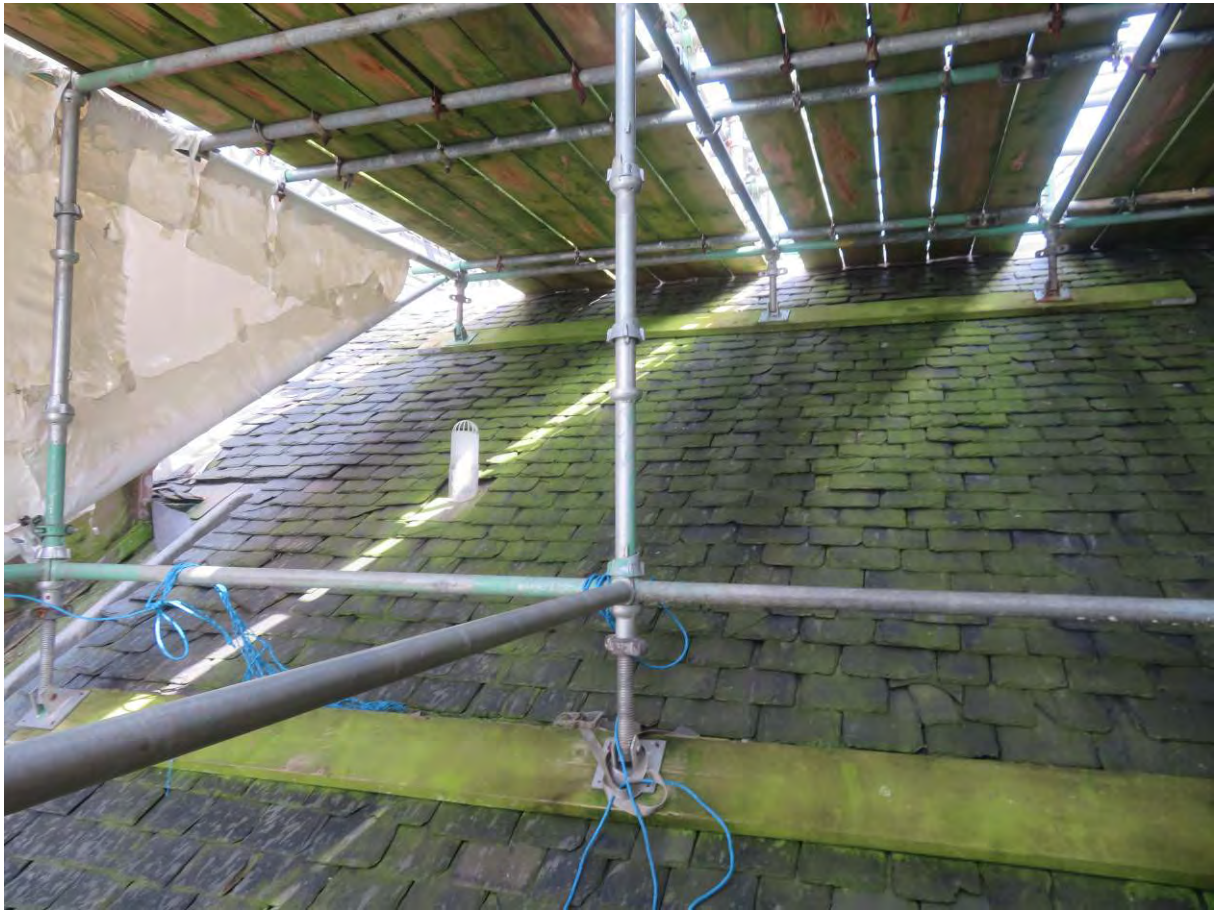
Photograph 87: Roof to dog-leg between Tower and South Range to south side

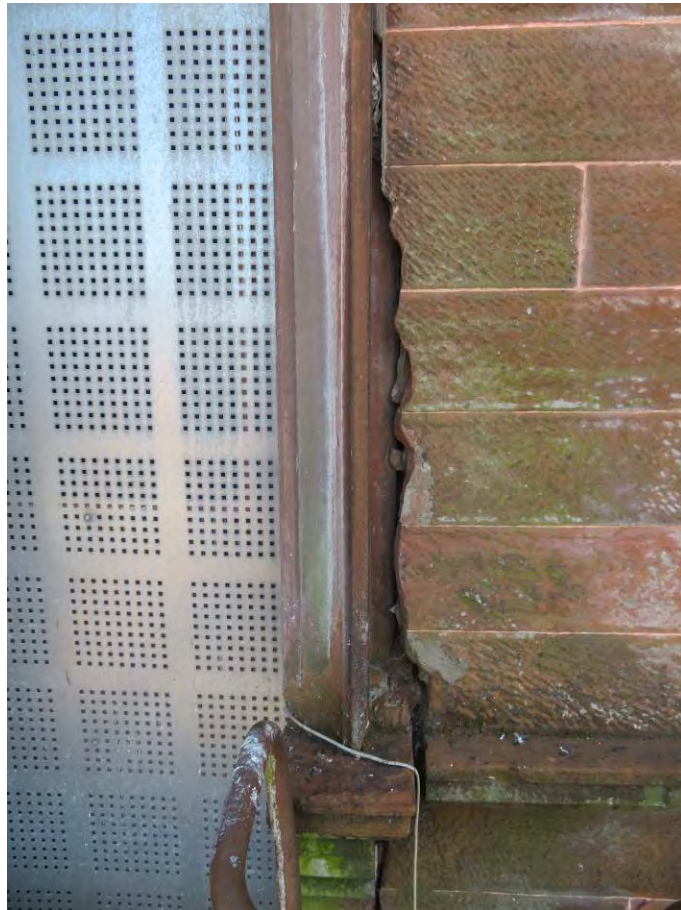
Photograph 99: Cracking to door reveal from fire escape

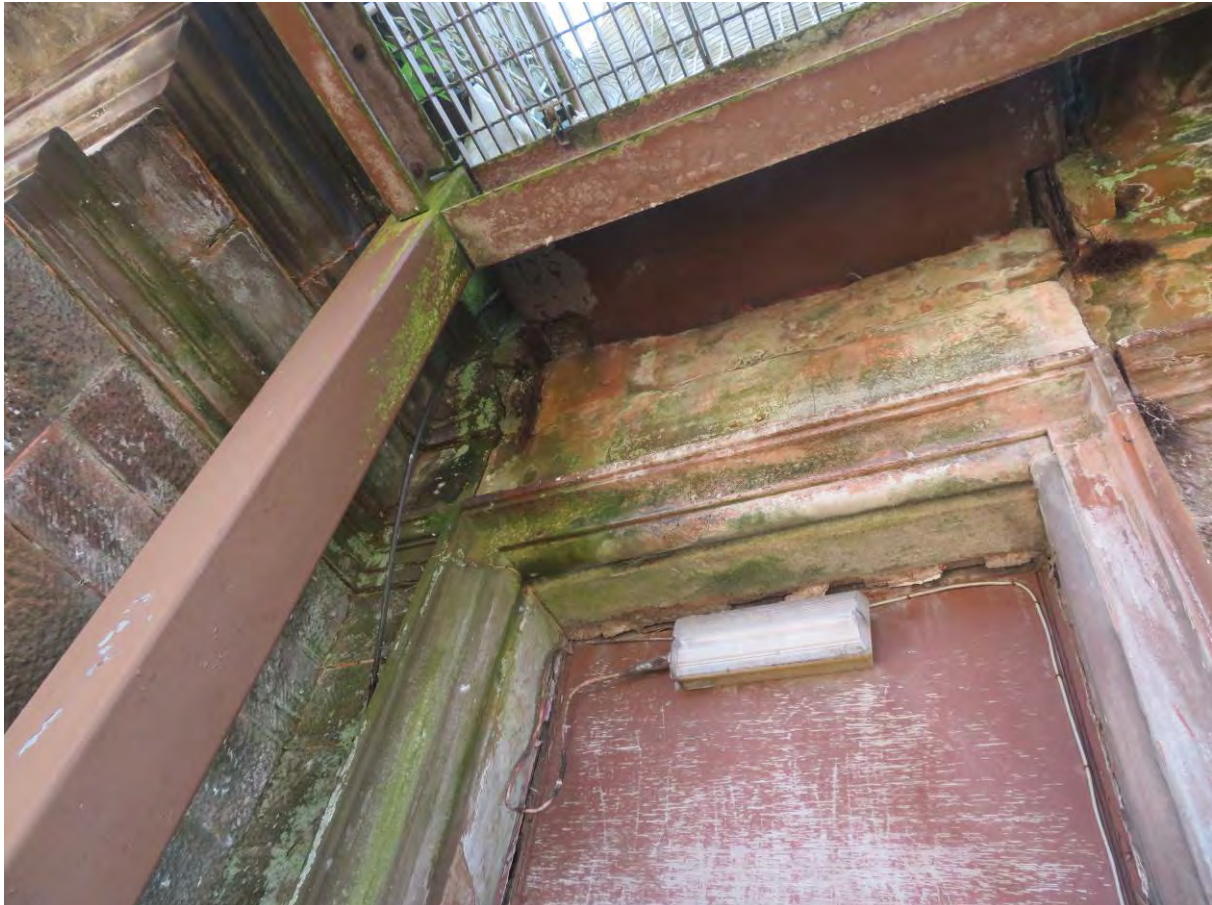
Photograph 100: In-built steel causing stone damage where corroded

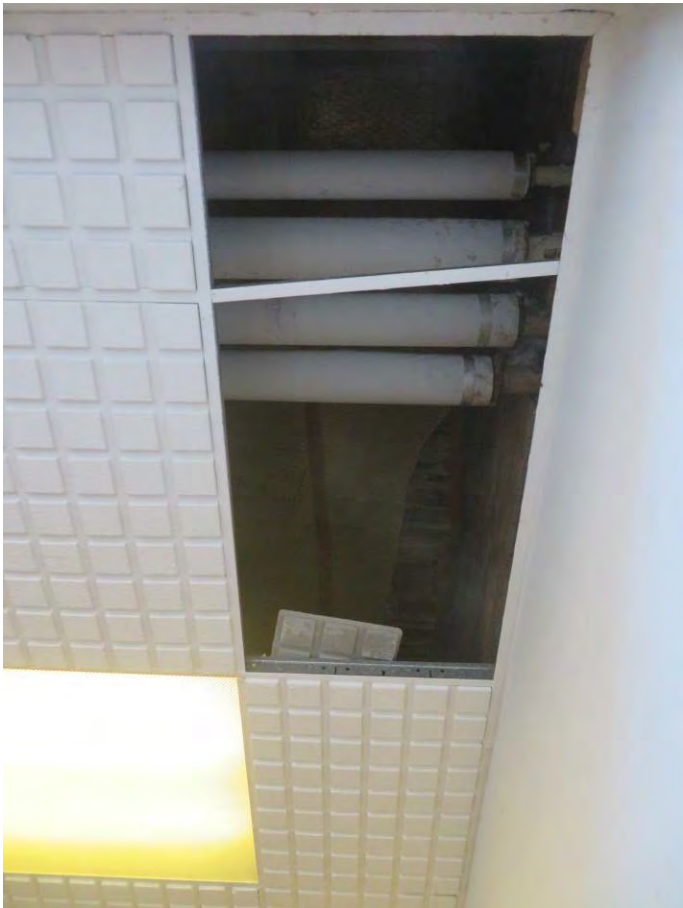
Photograph 101: Suspended ceilings in Scot Rail offices and Ticket Office
