The Morton Partnership
Structural Engineers

Registered in England No. 2727193

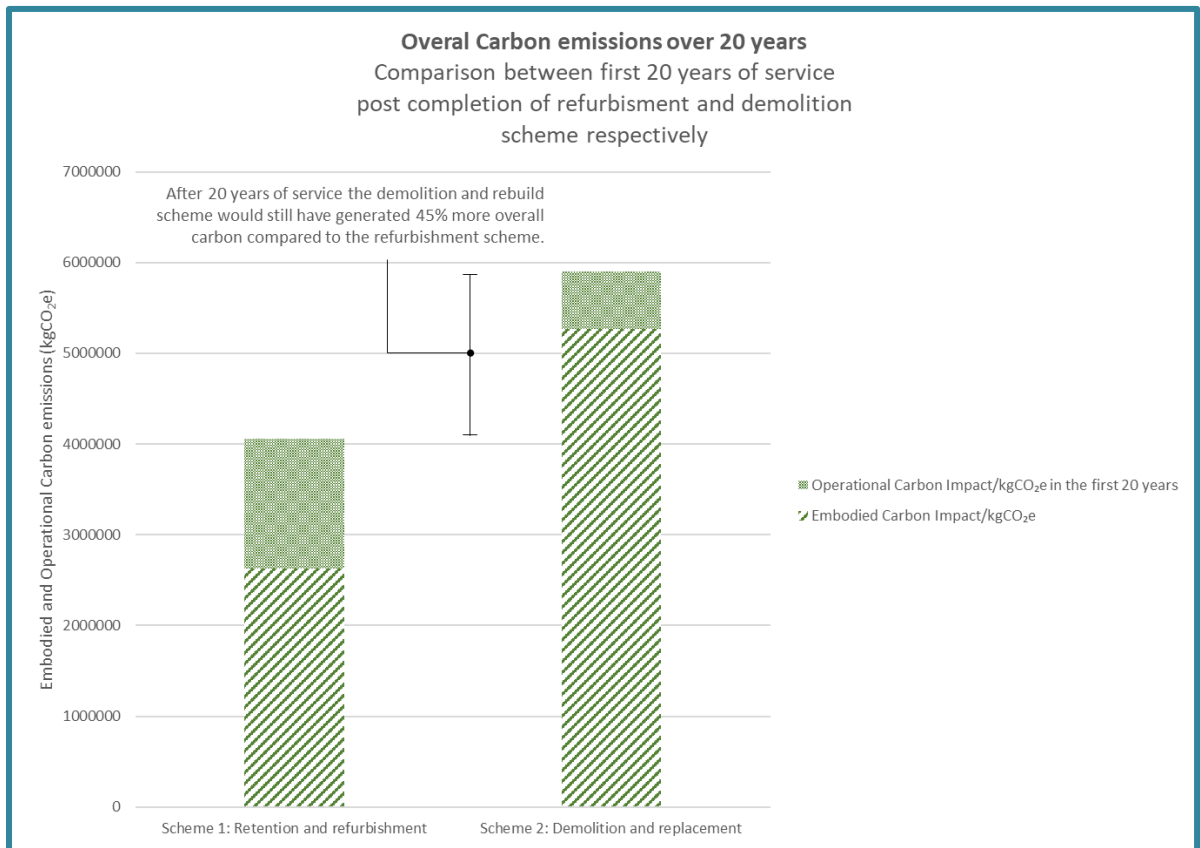
Figure 6 Comparison of combined effect of Embodied and Operational Carbon emissions (in kgCO₂e) between the two schemes over the first 20 years of service post construction completion.

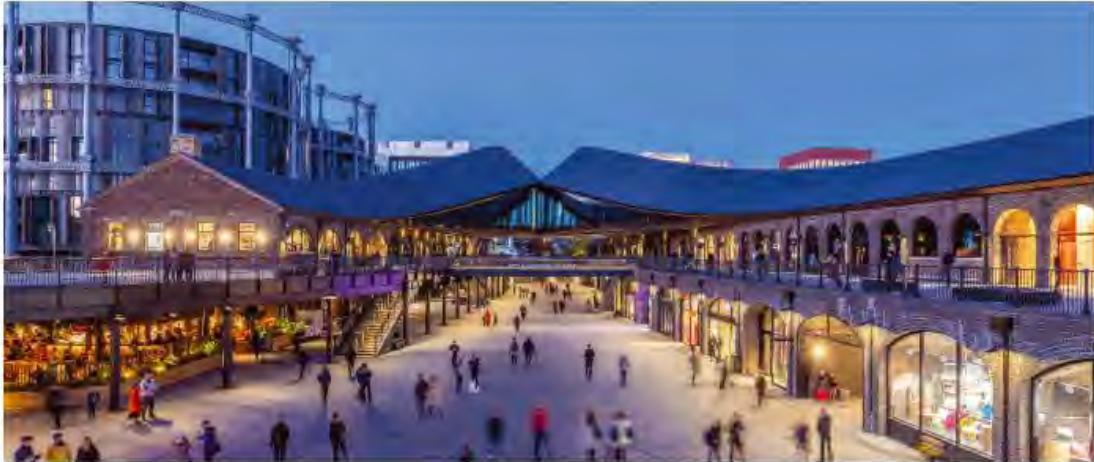
embodied carbon footprint of this project was only 240kg/m² (substructure + superstructure) due to the extensive reuse opportunities found in the scheme.

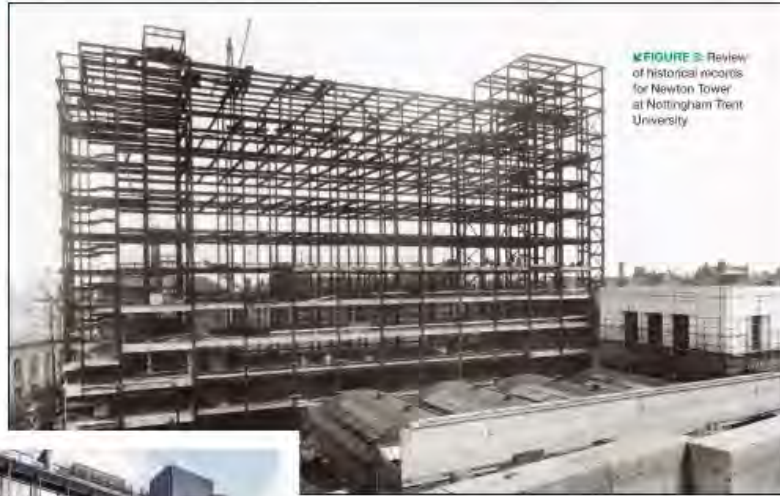
FIGURE 3: Review of historical records for Newton Tower at Nottingham Trent University

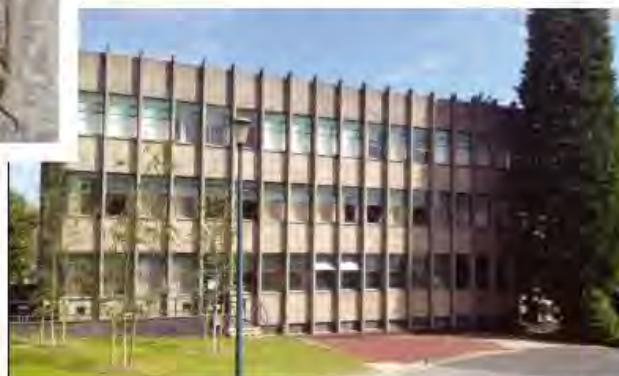
FIGURE 6: Major structural defects were uncovered at George Green Library, University of Nottingham

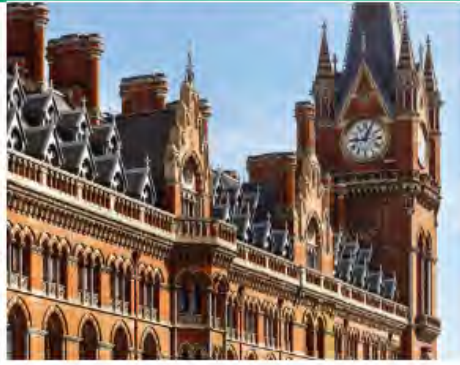
When is refurbishment possible?

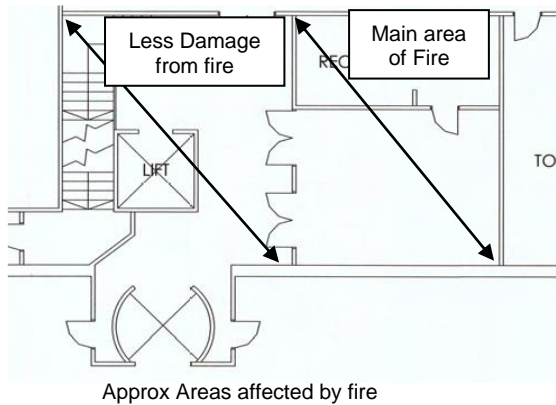
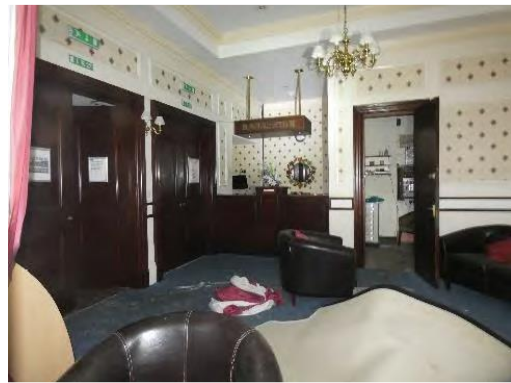
Room prior to fire from MM report ref FO02

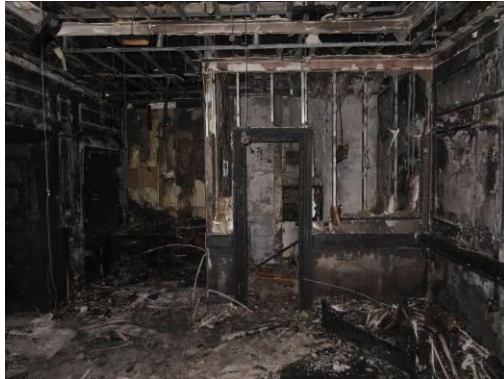
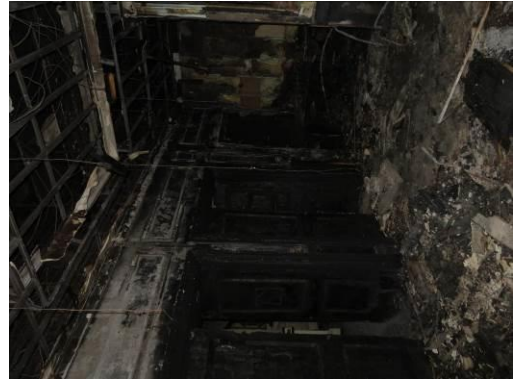
14.8 Basement - Internals

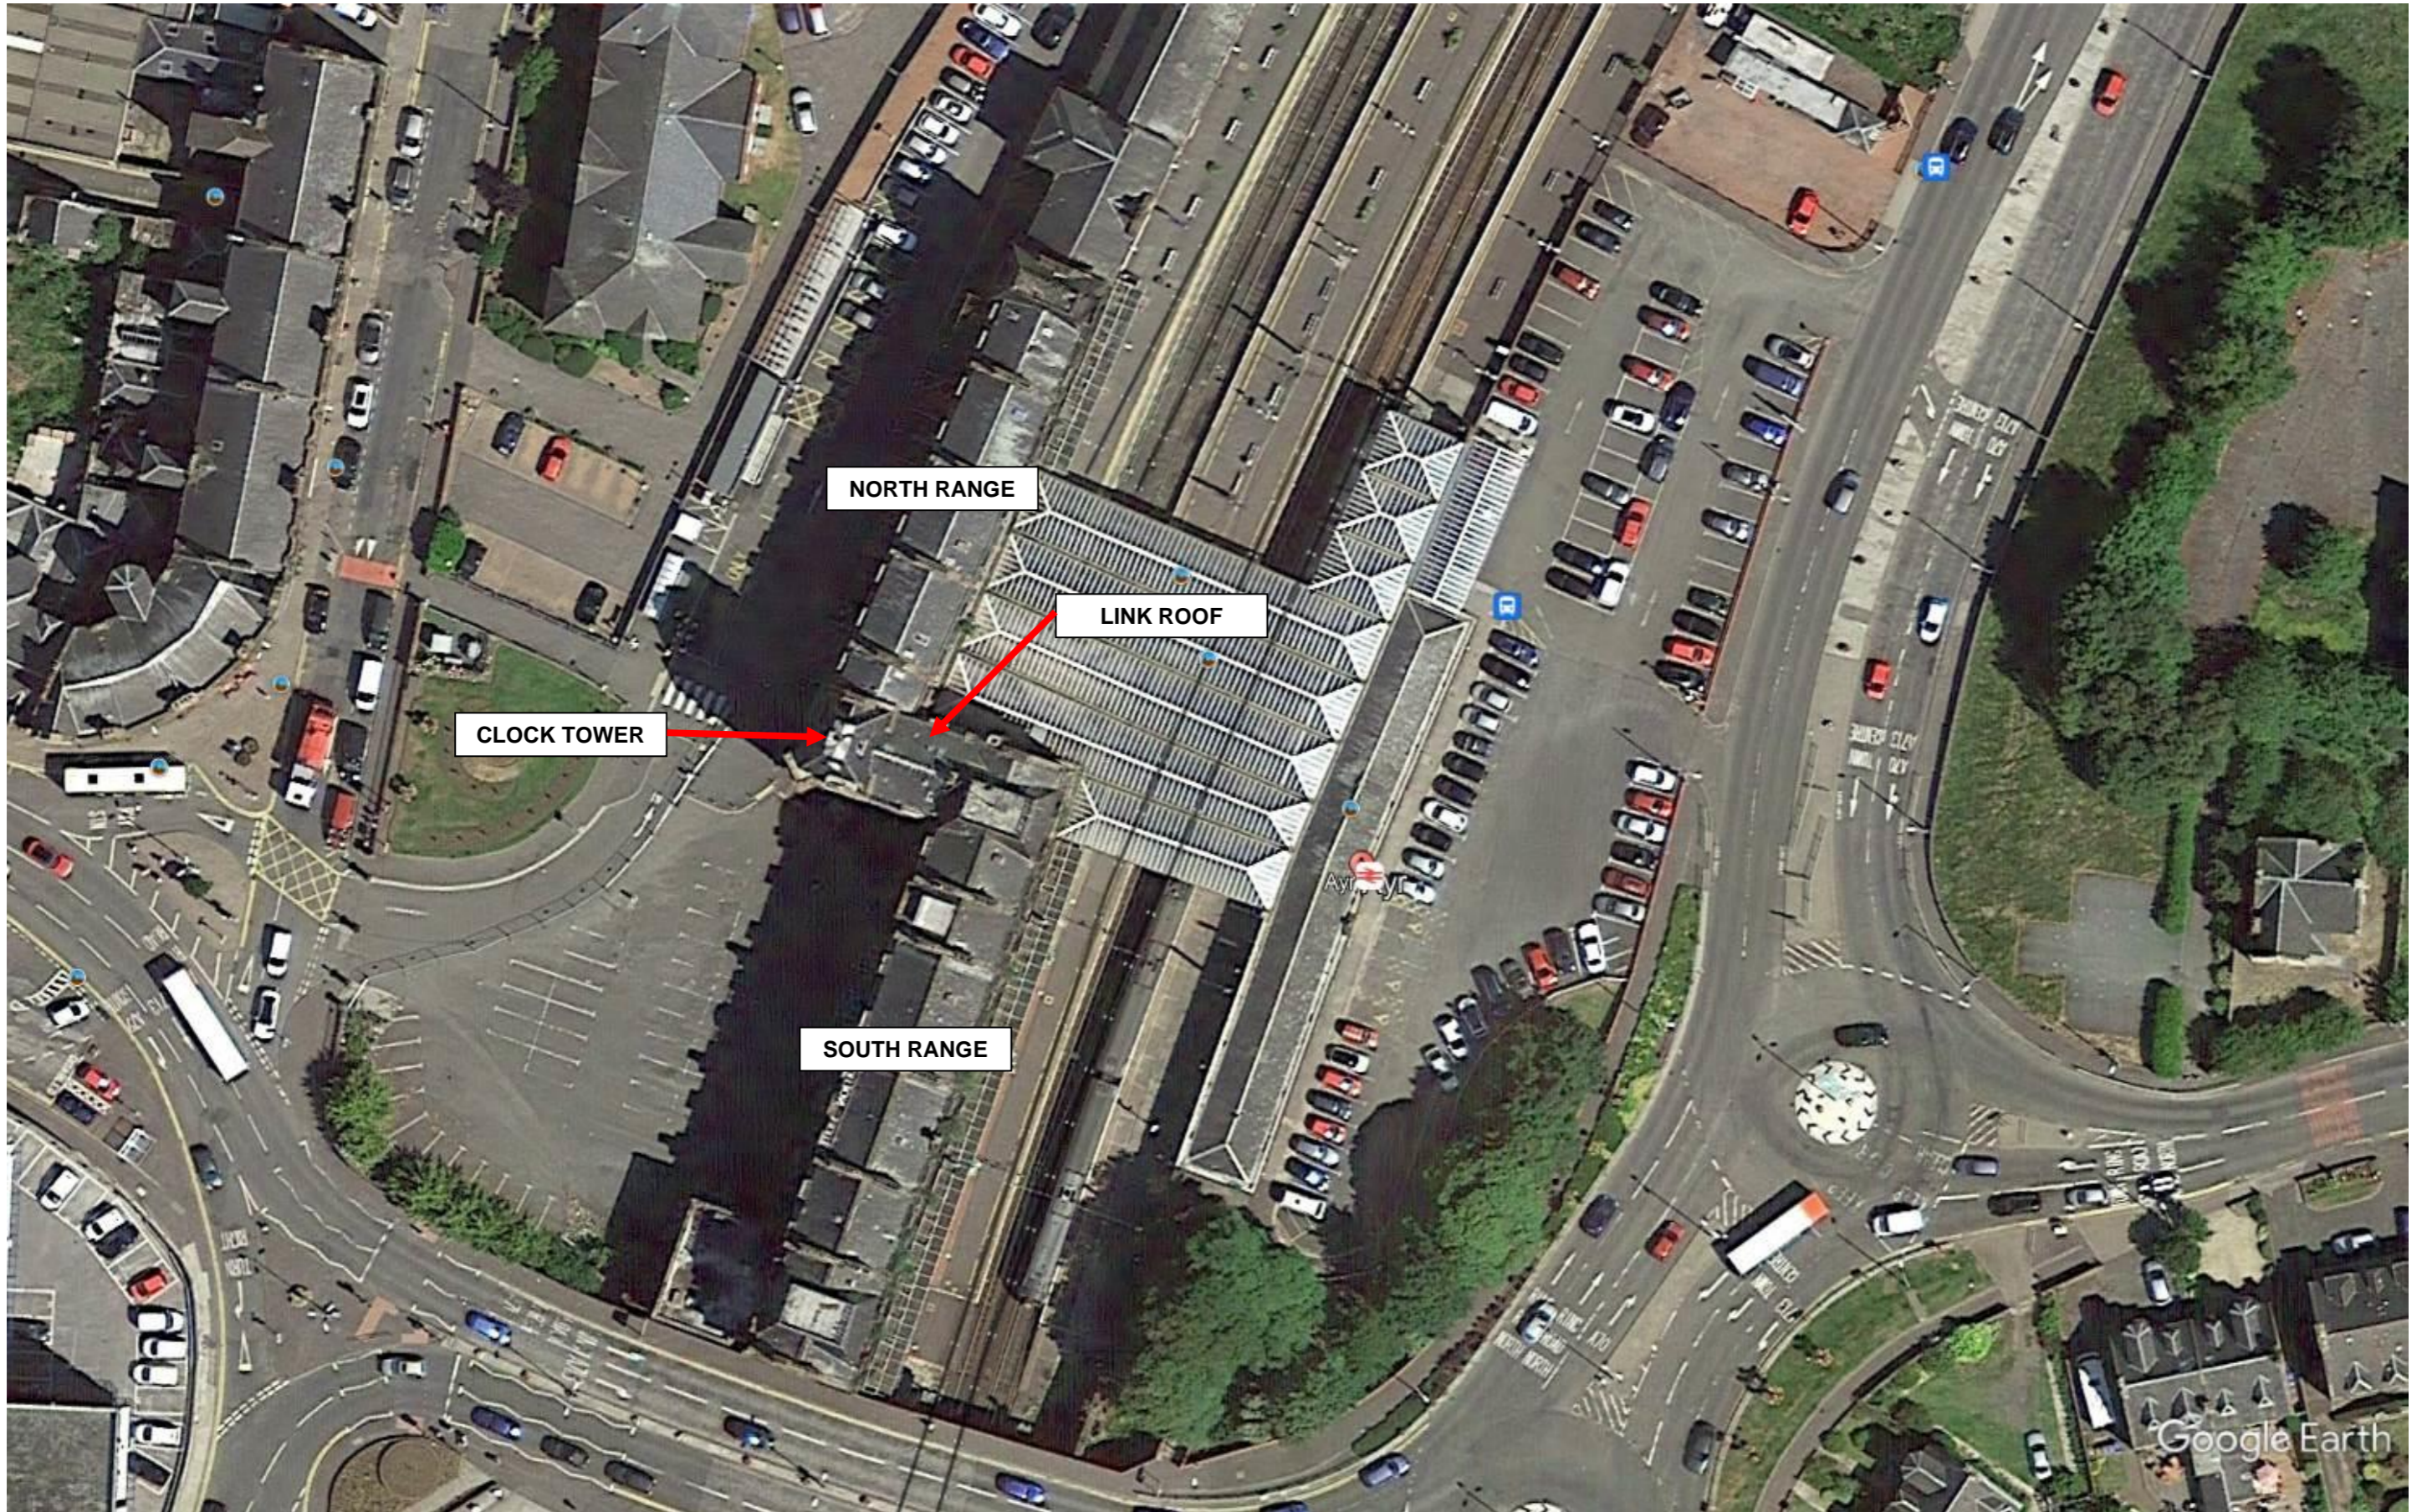
APPENDIX D
AERIAL VIEWS AND REFERENCING
